Job Information

Job #:	96541				Date:	February 10, 2020
Priority:	_	Authorized OT:	No	Authorized by:

Manufacturer:	Toshiba	Enclosure :	Totally Enclosed Fan Cooled
Serial#:	96806430	Model#:	B0752FLG3UM01
Service Factor:	1.15	Frame:	365TS
Horsepower/kW:	75	Rated RPM:	3545
Rated Amps:	178/89	Rated Voltage:	230/460
Phase:	3	Cycles:	60

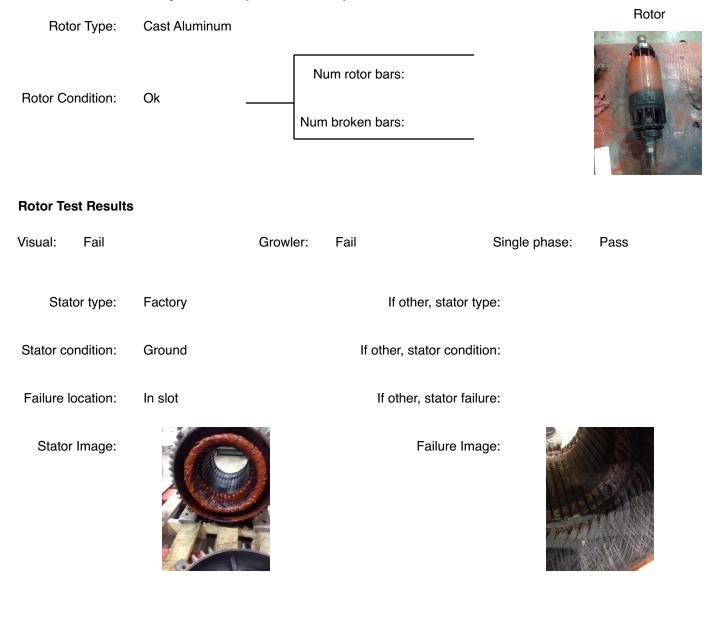
AC Electrical Inspection (Continued)

Winding color	: Painted	Winding	g image	Winding Therma	I Protection: No
Winding condition	: Charred				
Winding Therma Protection DE					
Winding Therma Protection ODE					
Stator test results	: Rewind				
Megs incoming:	Good	Surge incoming:	Good	Hi-pot in	coming: Good
Winding Resistanc	e Incoming				
Р	hases A to B	Phases B to C	Phase	es C to A	Resistive imbalance
Incoming (0.00	0.00	0.00		
Leads/ju	mpers: Ok		Lea	d jumper Image. :	
If other, leads/ju	mpers:				
Mechanical I	nspection				
Inspect bolt holes ar	nd fasteners. Valida	te correct fasteners.

Rotor is blown, stator windings are blown, iron has core damage, both end bells are over sized, shaft is bent, both bearing fits on shaft are under sized, DE bearing gave out and fail apart, a bolt for the ODE end bell is broke and still in housing, DE grease insert is missing, bolts for J-box cover are missing. Recommend new bearings, new shaft, new rotor, rewind, core repair, and new bolts, and machine work.
