# **Job Information**

Job #:	96661				Date:	March 16, 2020
Priority:	_	Authorized OT:	No	Authorized by:

Name:	AR Industrial Machinery		Reason:	
Contact:		Motor#:		PO#:
Application:	_	Special notes:

Manufacturer:	Siemens	Enclosure :	Totally Enclosed Fan Cooled
Serial#:		Model#:	
Service Factor:	1.15	Frame:	250M
Horsepower/kW:	100	Rated RPM:	3580
Rated Amps:	230-114	Rated Voltage:	230/460
Phase:	3	Cycles:	60
Special design:	No

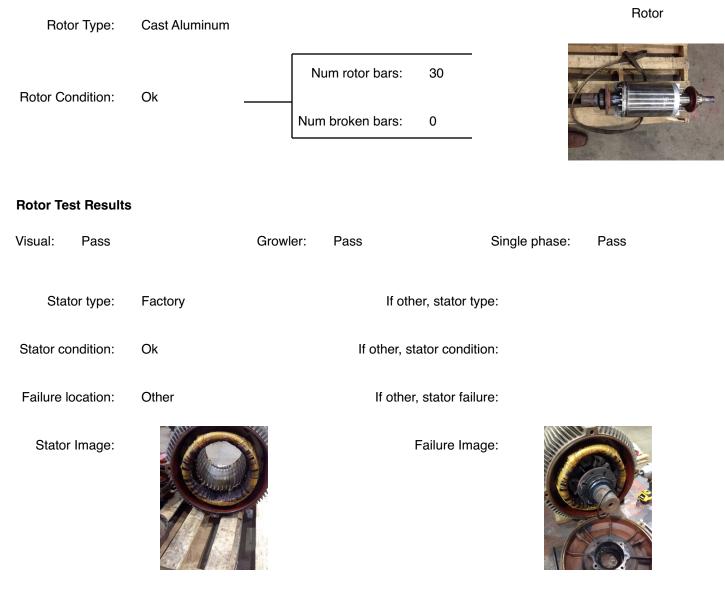
## **AC Electrical Inspection (Continued)**

Number of leads:	12	Terminal Markings:		
Length of leads:	43in	REF: NEMA Std Markings Identifi	s. MG 1-2009, Rev. 1- ied By Color:	2010, 2.41-Terminal
Size of leads:	F1	1-Blue 2-White 3-Orange	5-Black 6-No color assigned 7-No color assigned	P1-No color assigned P2-Brown
Lead condition:	Good	4-Yellow	8-Red	
Lug type:		Connections As Re	ceived:	
Lug Condition:	Bad		Terminal	Lugs
Lug size:				
Lug Attachment:	_
