Job Information

Job #:	97218				Date:	August 19, 2020
Priority:	_	Authorized OT:	No	Authorized by:

Manufacturer:	Siemens	Enclosure :	Totally Enclosed	Enclosure Type image
Serial#:		Model#:	Fan Cooled	
Service Factor:	1.15	Frame:	444T	
Horsepower/kW:	125	Rated RPM:	1785	and the second
Rated Amps:	143	Rated Voltage:	460	600
Phase:	3	Cycles:	60	
Special design:	No

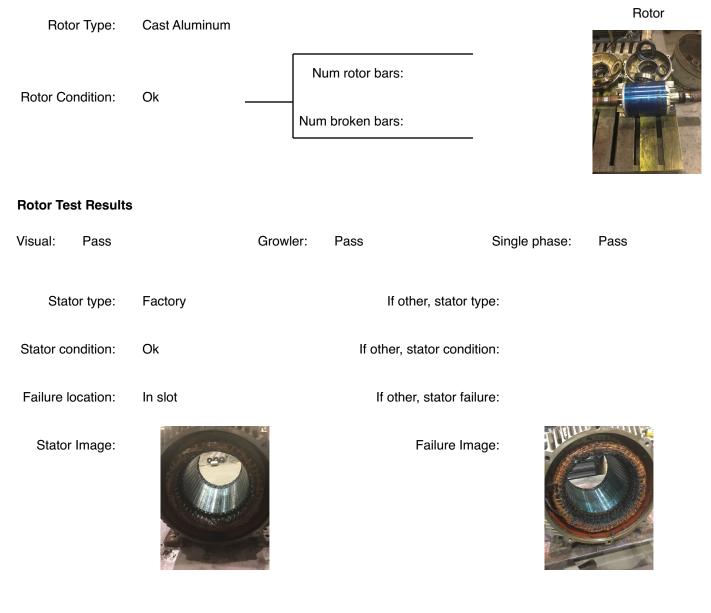
AC Electrical Inspection (Continued)

Winding colo	or:	Like new	Winding	ı image	Winding Thermal I	Protection: I	No		
Winding condition	ו :	Solid	Ĭ						
Winding Therm Protection DI		_							
Winding Therm Protection ODI		_							
Stator test result	s:	Salvageable							
Megs incoming:	Go	od	Surge incoming:	Good	Hi-pot inco	oming: Goo	d		
Winding Resistand	ce In	coming							
F	Phase	es A to B	Phases B to C	Phase	es C to A	Resistive imbala	ance		
Incoming	0.00		0.00	0.00		0.00			
Leads/ji	umpe	ers: Ok							
lf other, leads/ji	umpe	ers:
