Job Information

Job #:	97255				Date:	August 27, 2020
Priority:	_	Authorized OT:	No	Authorized by:

Name:	Bemis		Reason:	
Contact:		Motor#:		PO#:
Application:	_	Special notes:

Manufacturer:	Magnetek	Enclosure :	Totally Enclosed Fan Cooled
Serial#:	BN 09	Model#:	CAT#T348
Service Factor:	1.15	Frame:	215T
Horsepower/kW:	10	Rated RPM:	1740
Rated Amps:	26/13	Rated Voltage:	230/460
Phase:	3	Cycles:	60
Special design:	No

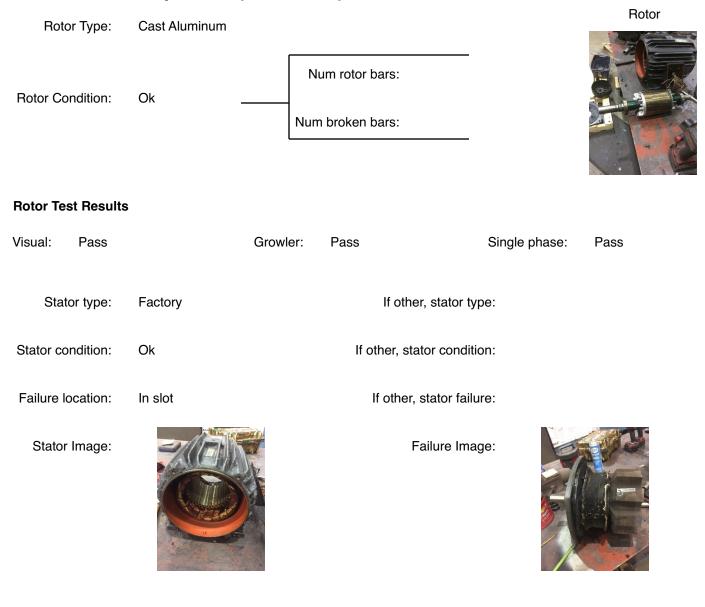
AC Electrical Inspection (Continued)

Winding color:	Like new	Winding	ı image	Winding Therma	Protection	Yes
Winding condition :	Solid					
Winding Thermal Protection DE:	_					
Winding Thermal Protection ODE:	_		5			
Stator test results:	Salvageable					
Megs incoming: Go	od	Surge incoming:	Good	Hi-pot in	coming:	Good
Winding Resistance Inc	coming					
Phase	es A to B	Phases B to C	Phase	es C to A	Resistive i	mbalance
Incoming						
Leads/jumpe	ers: Ok					
If other, leads/jumpe	ers:
