Job #:	142276	Date:	April 10	, 2020
--------	--------	-------	----------	--------

Manufacturer: Rossi Ratio:

# **Gearbox Visual Inspection**

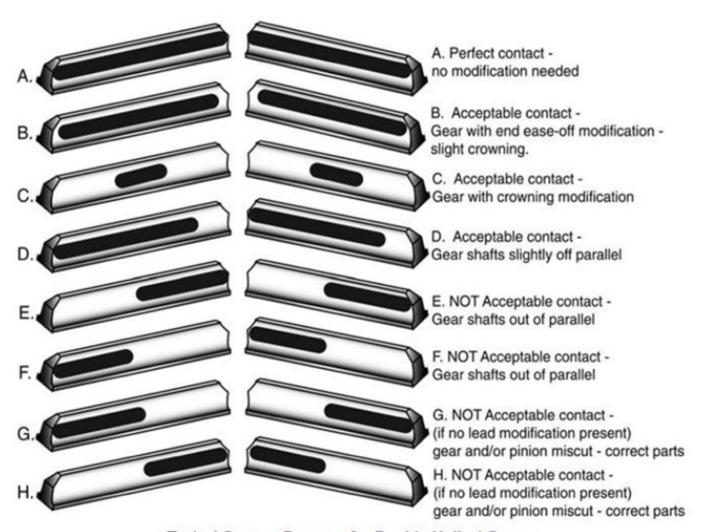
#### 27. Identify type of gear tooth contact

Typical Contact Patterns for Double Helical Gears
