### **Job Information**

# **Gearbox Visual Inspection**

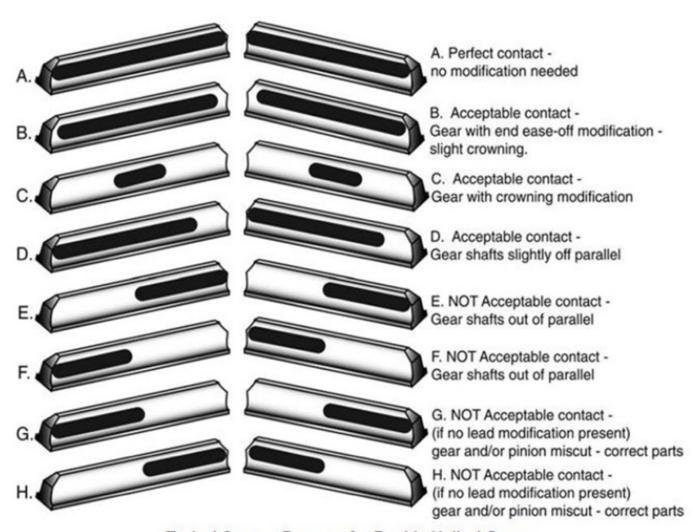
#### 27. Identify type of gear tooth contact

Typical Contact Patterns for Double Helical Gears

26. Gear tooth contact Damaged
