AC Recondition As Found

AC Recondition - Rev. 2

Location: # 1 Penthouse Serial Number: Q2-D16T0348NPI 7

Hi-Speed Job Number:	147802
Manufacturer:	Siemens
Product Number:	1LE23213CC112AA3
HP/kW:	40 (HP)
RPM:	1180 (RPM)
Frame:	364T
Voltage:	460
Current:	49 (Amps)
Phase:	Three
Hz:	60 (Hz)
Service Factor:	1.15
Enclosure:	TEFC
# of Leads:	3
J-box Included:	None
Coupling/Sheave:	None
Date Received:	05/31/2022
Bearing RTDs:	No
Stator RTDs:	No
Repair Stage:	Teardown Inspection
Rewind:	No
Heaters:	No
Winding Type :	Random Wound
Bearing Type:	Rolling Element

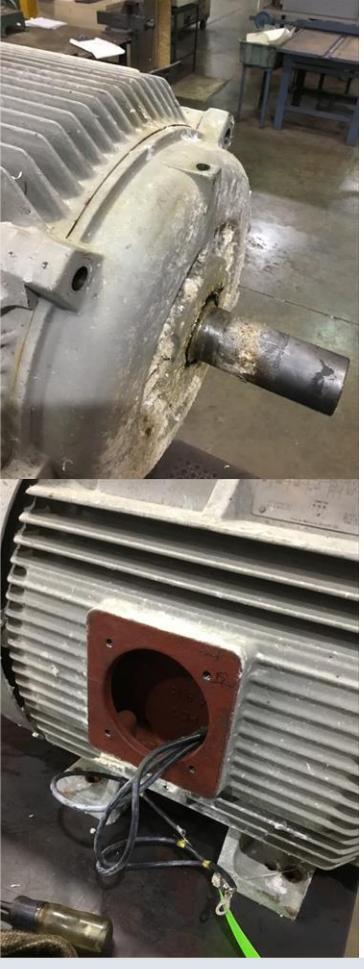
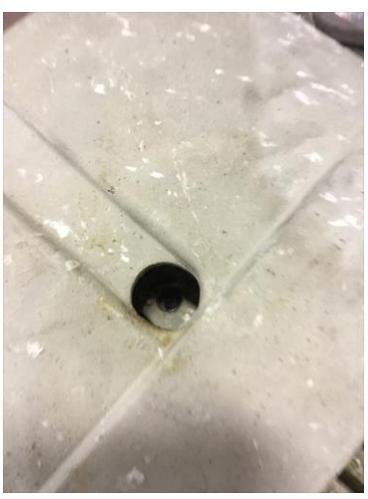
FolderID: 147802 FormID: 13728812 Describe the Overall Condition of the Equipment as Received Grease ports missing on both sides No j box
