7103 OLD MILLINGTON ROAD **MILLINGTON, TN 38053**

AC Recondit	ion - Rev. 2
Location:	Shop

Hi-Speed Job Number:	149655
Manufacturer:	Baldor
Spec/ID #:	A44-4469-1796
Serial Number:	A1307022094
HP/kW:	125 (HP)
RPM:	1785 (RPM)
Frame:	444T
Voltage:	460
Current:	139 (Amps)
Phase:	Three
Hz:	60 (Hz)
Service Factor:	1
Enclosure:	TEFC
# of Leads:	3
J-box Included:	None
Coupling/Sheave:	Coupling
Date Received:	02/27/2023
Bearing RTDs:	No
Stator RTDs:	No
Repair Stage:	Teardown Inspection
Heaters:	Yes
Winding Type :	Random Wound
Bearing Type:	Rolling Element

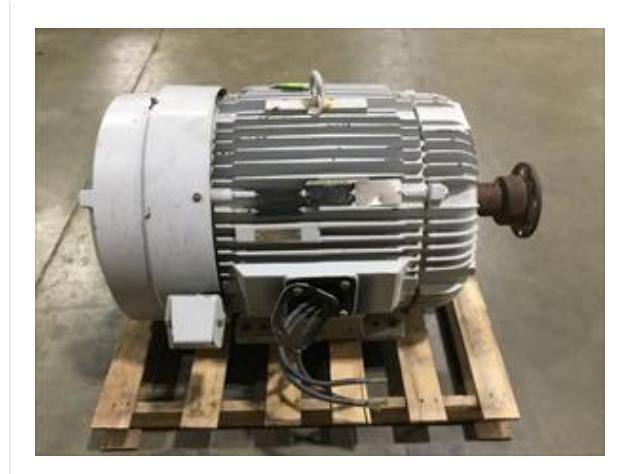
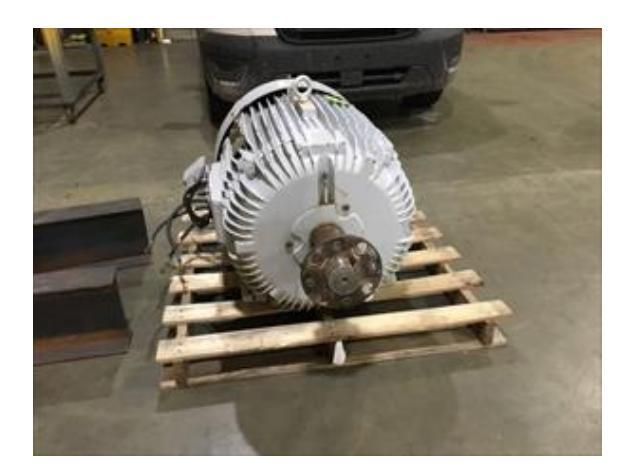
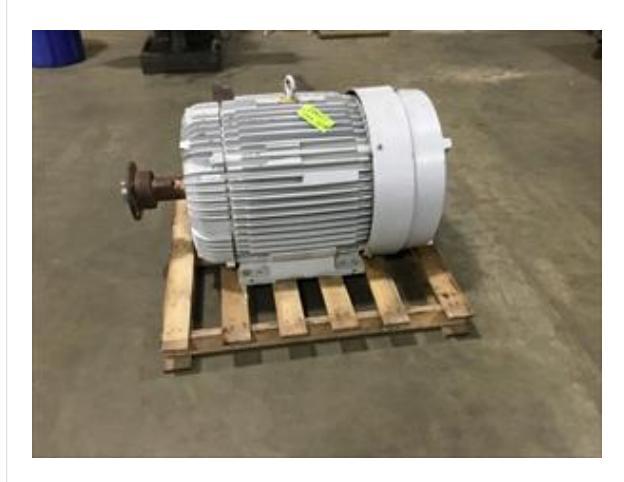
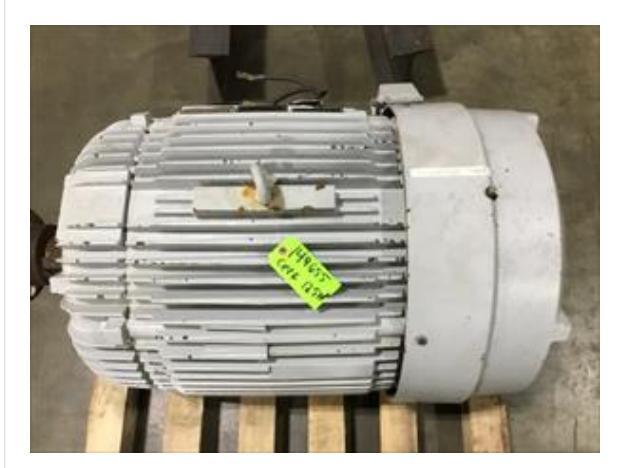
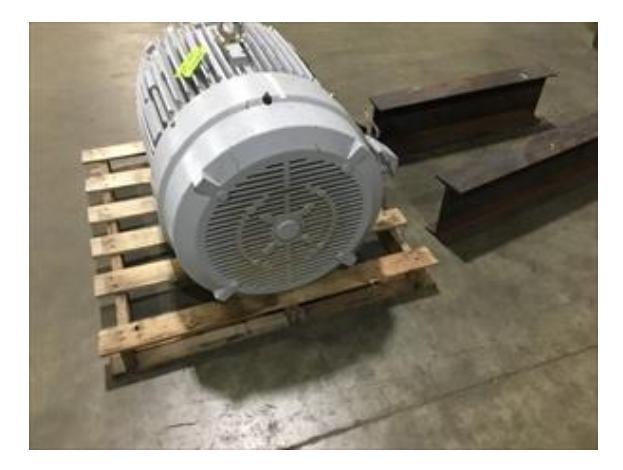
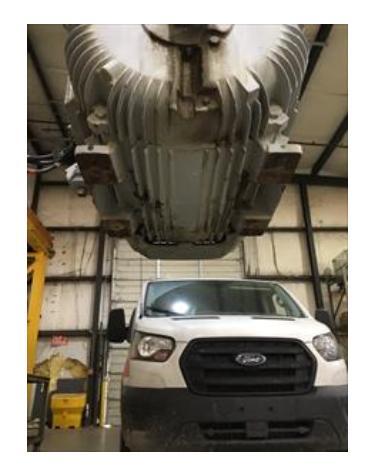
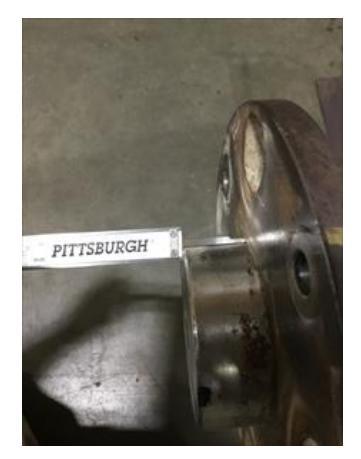
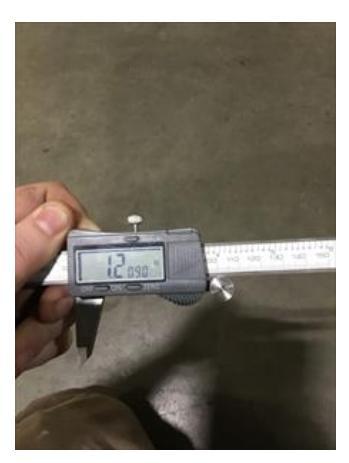
3. Photos of all six sides of the machine.

4.	Describe the Overall Condition of the Equipment as Receiv	ed	
	Rusty and dirty		
5.	Distance from the end of the shaft to the Coupling/Sheave	1.2 inches	
	See pics under all six sides		
Initial	Mechanical/Electrical		0
<b>6</b> .	Does Shaft Turn Freely?	(Yes) Yes	
7.	Does Shaft Have Visible Damage?	(No) No	
8.	Assembled Shaft Runout	0 Inches	
9.	Assembled Shaft End Play	0 inches	
10	. Air Gap Variation <10%	No provisions for measurement	
• 11.	. Lead Condition	(P) Pass	
	- Edd Edigit		
13.	. Frame Condition	Good	
• 14.	. Fan Condition	(P) Pass

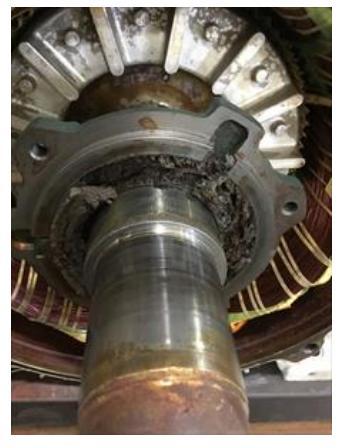
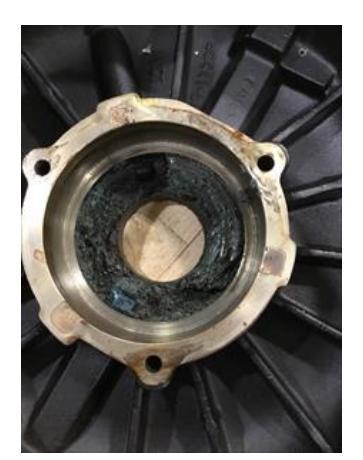
26. Drive End Lubrication Type

Looks like grease may of been mixed

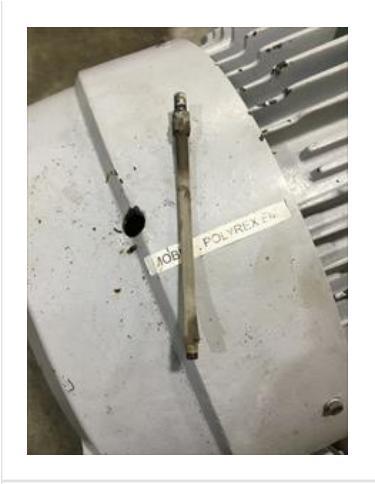
32.	Opposite Drive End Bearing Qty.	1	
33.	Opposite Drive End Bearing Type	(Ball) Ball Bearing	
34.	Opposite Drive End Lubrication Type	(Grease) Grease Lubricated	P36
