AC Recondition As Found

Big River Steel (004767)

Location:	Motorshop	
Serial Number:	1048013762	
Description:20hp Ac Motor

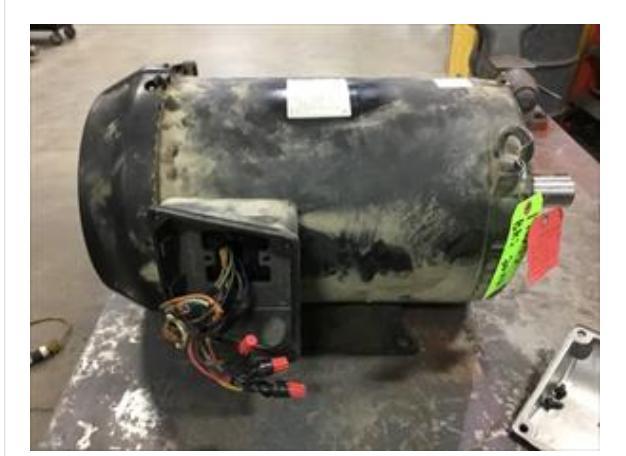
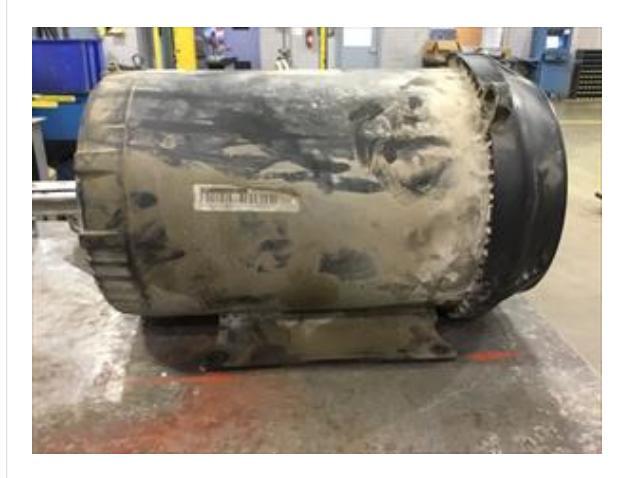
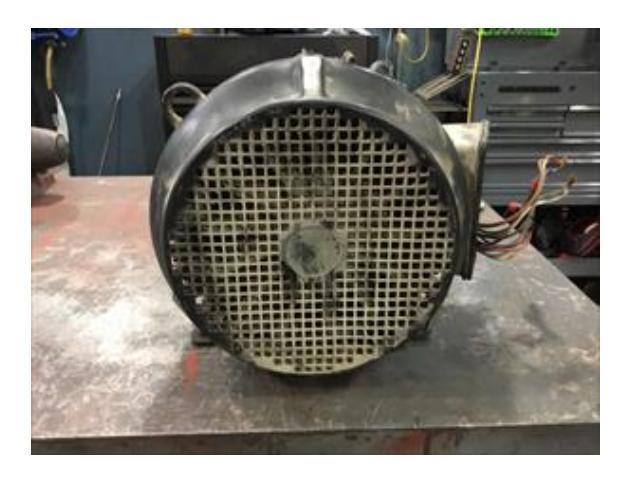
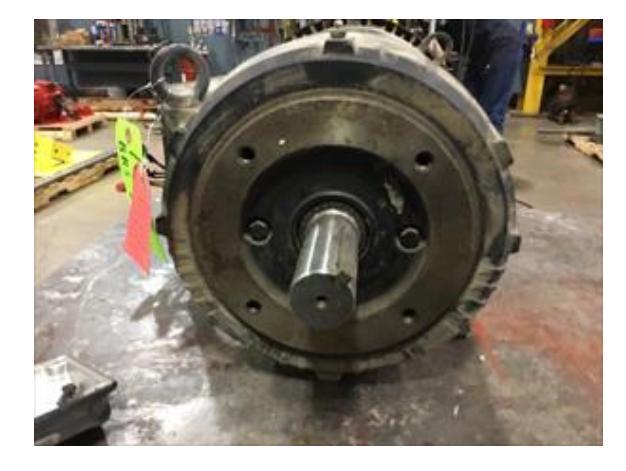
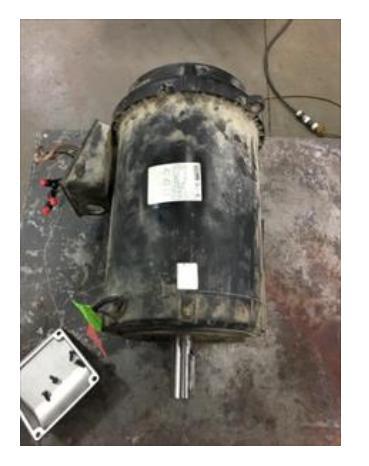
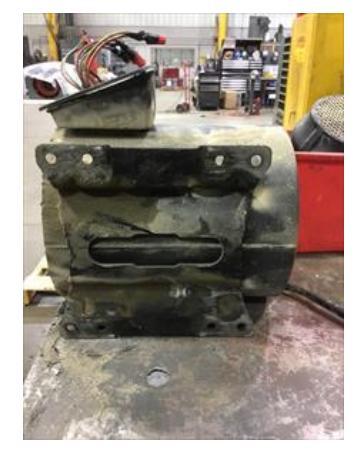
3. Photos of all six sides of the machine.

4. Describe the Overall Condition of the Equipment as Received New endbell required and rewind

New chaben required and remina	
In	itial I	Mechanical/Electrical	
	5.	Does Shaft Turn Freely?	(Yes) Yes
	6.	Does Shaft Have Visible Damage?	(No) No
	7.	Assembled Shaft Runout	0.0005 Inches
	8.	Assembled Shaft End Play	0.003 inches
	9.	Air Gap Variation <10%	No provisions for measure
	10.	Lead Condition	(P) Pass

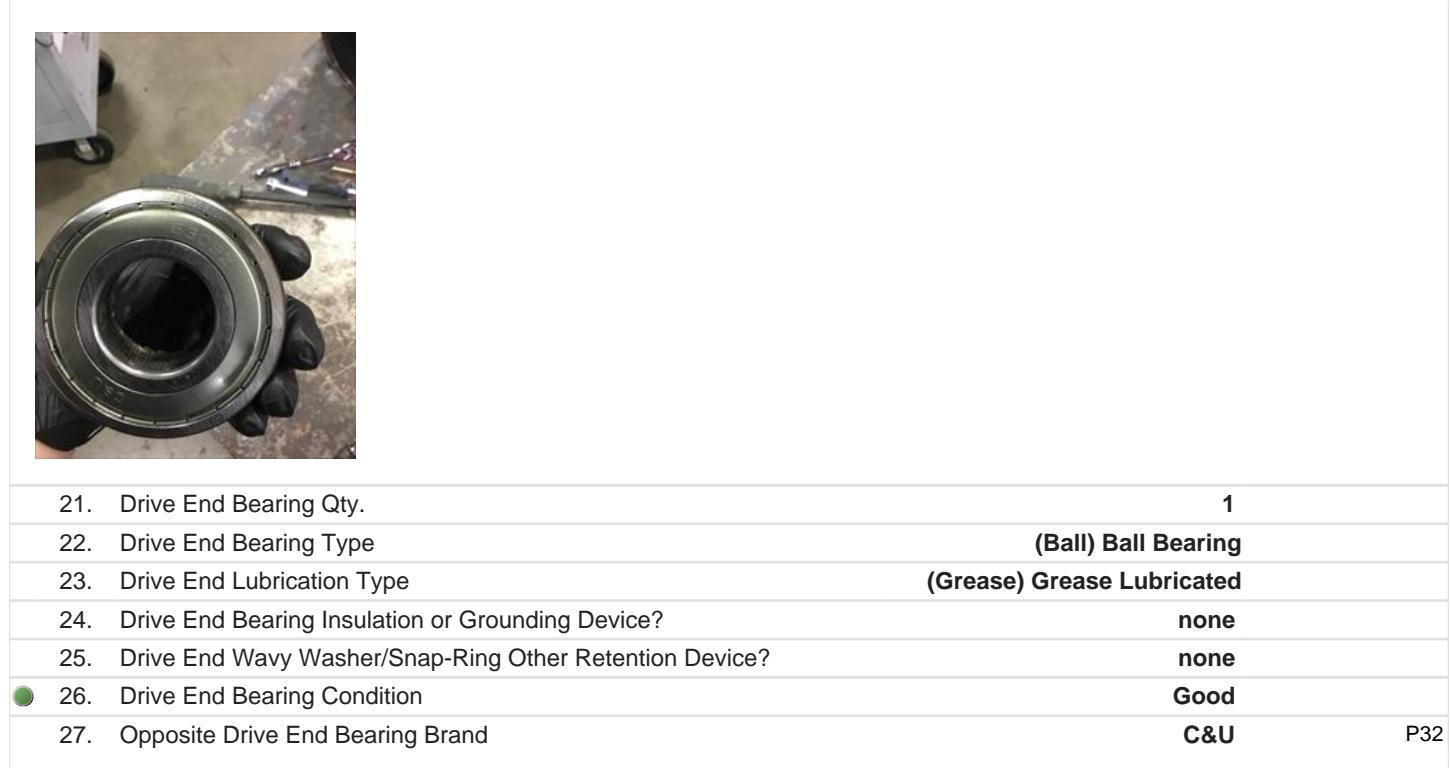
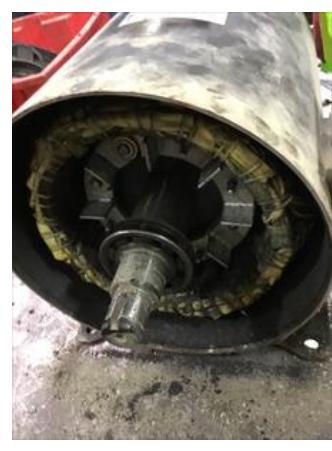
11.	Lead Length			10 Inches	P12
	12.	Frame Condition			good	
	13.	Fan Condition			(P) Pass	
	14.	Broken or Missing Components		One	end bell bolt broke	
	•	One end bell bolt broke				
In	itial I	Electrical Inspection				o
	15.	Insulation Resistance/Megger			0 Megohms	P19
	16.	Winding Resistance				
		1-2	1-3	2-3		
		0	0	0		
	17.	Perform Surge Test			(F) Fail	
	18.	Stator Condition			needs rewind	
Μ	echa	nical Inspection				0
	19.	Drive End Bearing Brand			C&U

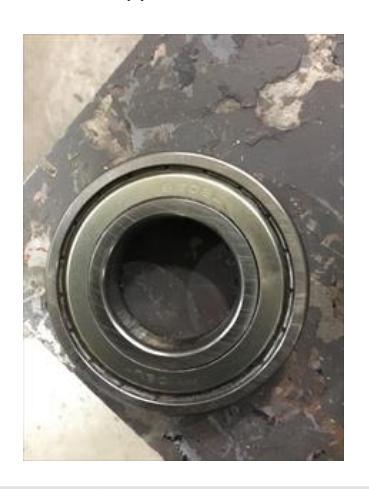
28. Opposite Drive End Bearing Number-

6208z

29.	Opposite Drive End Bearing Qty.	1
30.	Opposite Drive End Bearing Type	(Ball) Ball Bearing
