**AC Recondition As Found**

AC Recondition - Rev. 2					
Location: Shop					
Serial Number:					
Description:300	Description:300 Hp AC Stator

Hi-Speed Job Number:	149801
Manufacturer:	Reliance
Product Number:	39244272 RCP-406
Spec/ID #:	01MIN87052 G001 KC
HP/kW:	300 (HP)
RPM:	1785 (RPM)
Frame:	449 TDZ
Voltage:	460
Current:	336 (Amps)
Phase:	Three
Hz:	60 (Hz)
Service Factor:	1.15
Enclosure:	DP
# of Leads:	12
J-box Included:	None
Coupling/Sheave:	None
Date Received:	03/17/2023
Bearing RTDs:	No
Stator RTDs:	No
Repair Stage:	Teardown Inspection
Heaters:	Yes
Winding Type :	Random Wound
Bearing Type:	Rolling Element

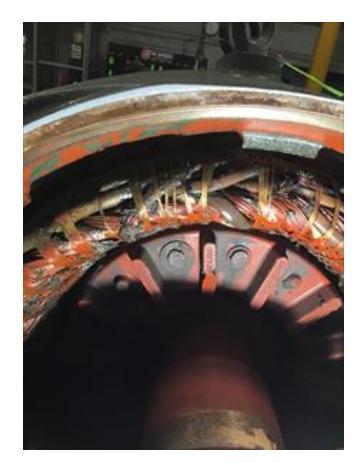
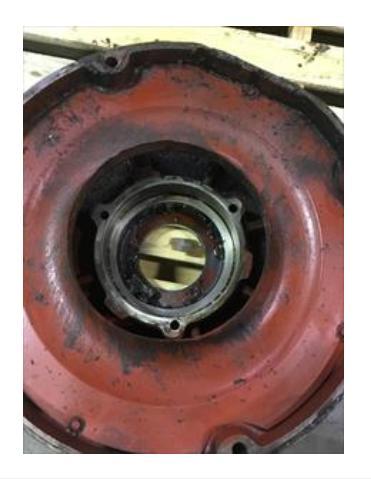
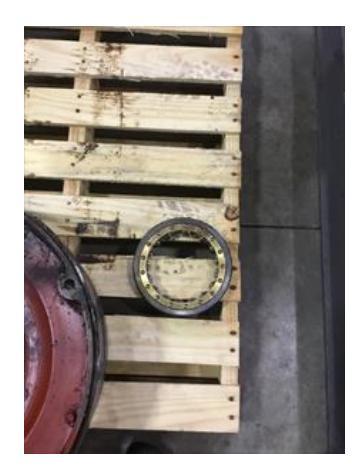
Insulation is deteriorating

4. Describe the Overall Condition of the Equipment as Received Leads need replaced and insulation is deteriorating due to oil filled stator for a reliable machine I would recommend rewinding

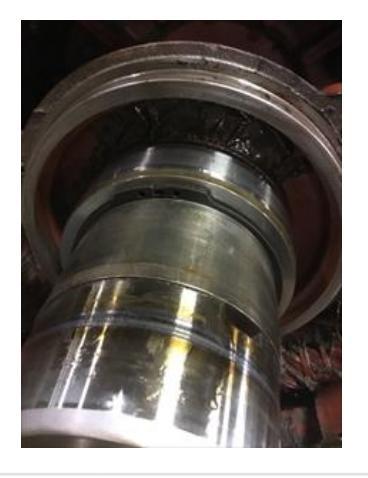
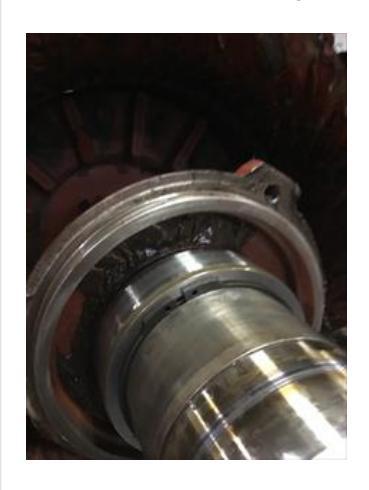
28. Drive End Bearing Condition

No grease left

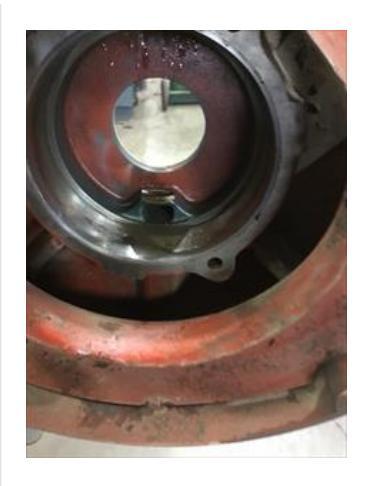
Water in the end bell
