September 27, 2023

Darrell Davis PMC-Biogenix Memphis, TN

The following is a summary report for the vibration analysis that was performed on seven specific pieces of equipment on 9/19/23. This report will only contain defects that were found according to the data collected.

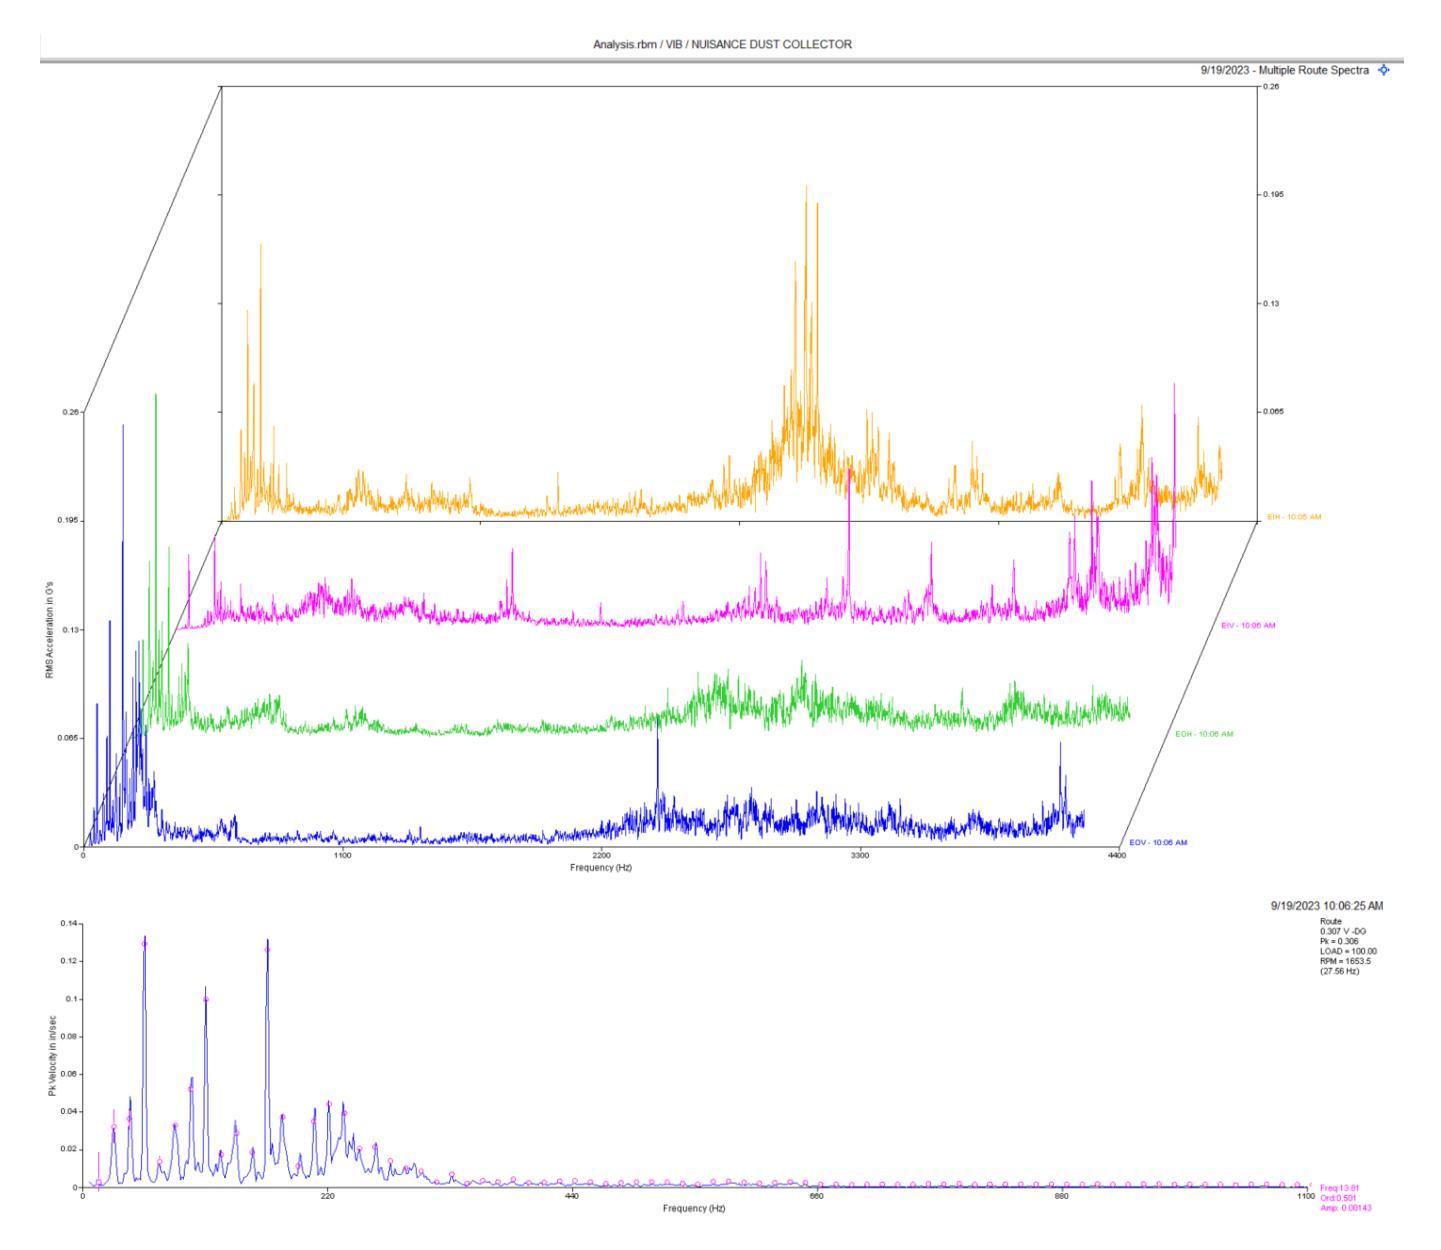
Nuisance Dust Collector CLASS I

Observation:

The first plot is a multipoint waterfall of the blower bearings. Data shows quite a bit of non-synchronous peaks and noise floor throughout the spectra. The second plot is the outboard bearing vertical of the blower. Data shows $\frac{1}{2}$ harmonics of rpm in the lower end of the spectrum.

Recommendation:

The noise floor, non-synchronous peaks, and ½ harmonics are indications of lubrication issue/bearing wear. It is recommended to inspect the blower bearings for defects and wear soon. Ensure bearings have adequate clean grease.

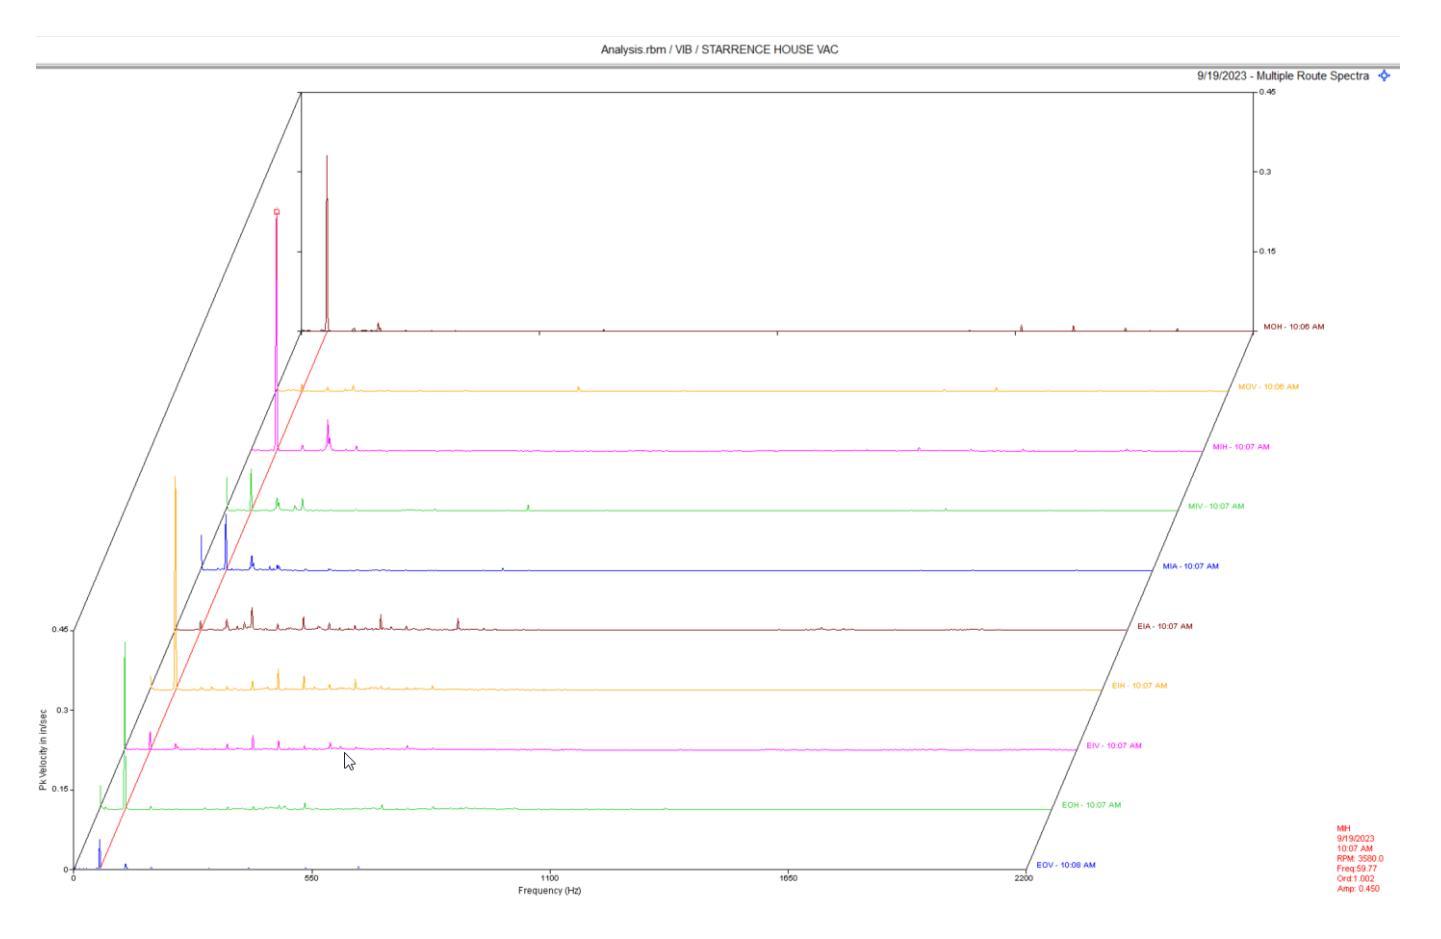
Starrence House Vac Pump CLASS II

Observation:

The multi-point spectra above is the motor and pump. Notice the large peak in the lower end of the spectra. This is 1 x rpm peak and is highest in the horizontal direction.

Recommendation:

Data suggests alignment or coupling issue may be the cause of the high horizontal vibration in the motor and pump. It is recommended to inspect the coupling and re-align the motor to the pump ensuring all base, motor, and pump fasteners are tight.

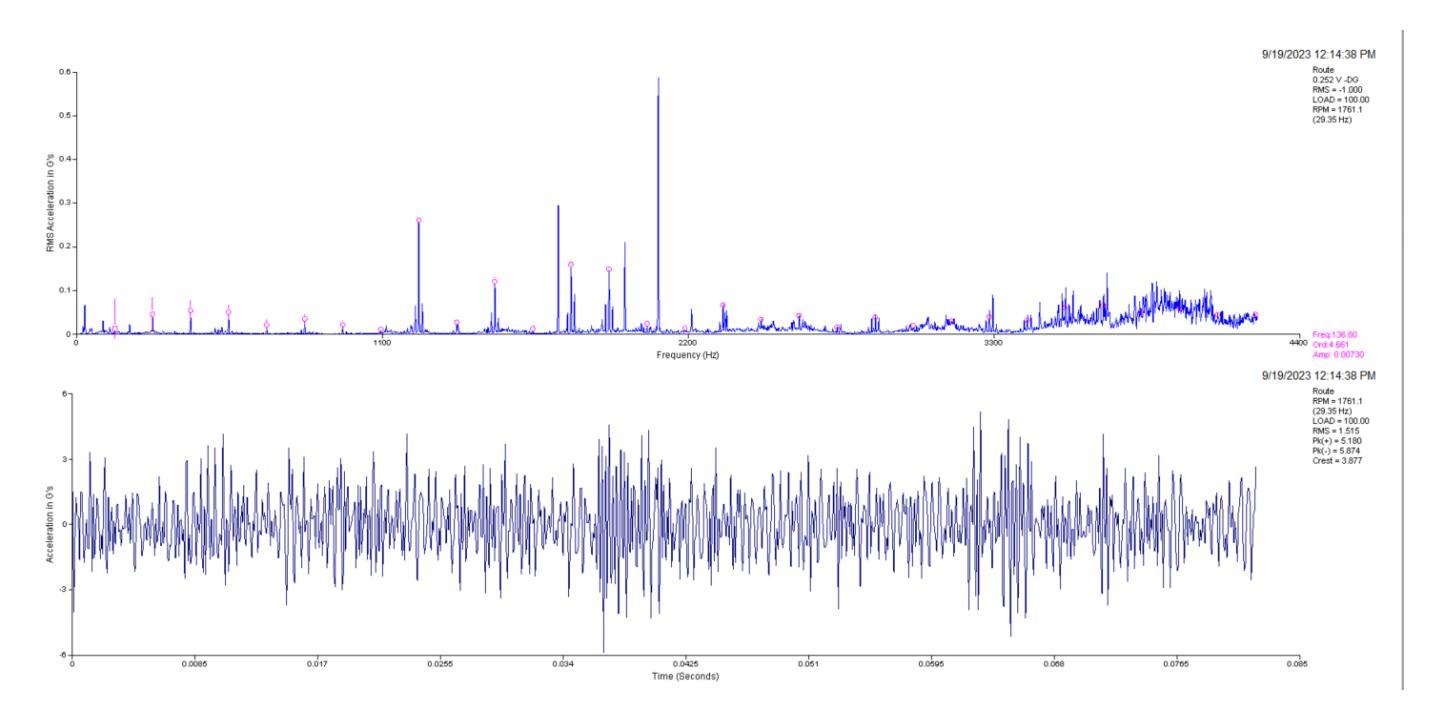
Emulsifier Spray Tower Blower (MOTOR) CLASS II

Observation:

Data above is the motor inboard vertical. The spectrum shows quite a bit of non-synchronous peaks. The marked peaks in the spectrum appear to be 4.661 orders of motor rpm indicating a likely bearing race/roller element defect.

Recommendation:

Data does indicate bearing issues in this motor. Severity is unclear as we do not have recent trend able data. It is recommended to inspect the motor as scheduling allows. Motor will likely need replacing in the near future.
