## AC Inspection as Found US Vanadium 6105 Cynamide

Description:1 HP WITH BRAKE

Hi-Speed Job Number:	102674
Manufacturer:	Baldor
Spec/ID #:	35Z659T65961
Serial Number:	F1708172306
HP/kW:	1 (HP)
RPM:	1725 (RPM)
Frame:	56CZ
Voltage:	460
Current:	.17
Phase:	Three
Hz:	60 (Hz)
Service Factor:	1.00
Enclosure:	TENV
# of Leads:	6
J-box Included:	Complete
Coupling/Sheave:	None
Date Received:	03/20/2024
Bearing RTDs:	No
Stator RTDs:	No
Repair Stage:	Final
Rewind:	Yes
Shaft Machined Fit Repairs Required:	No
Bearing Housing Machined Fit Repairs Required:	No
Heaters:	No
Winding Type :	Random Wound
Bearing Type:	Rolling Element

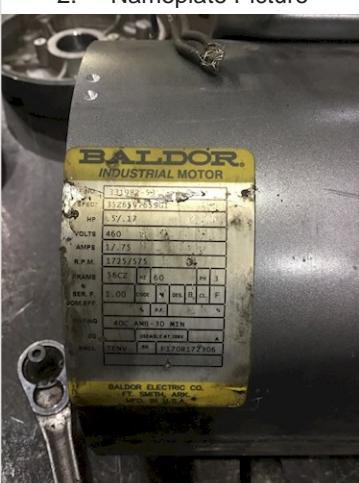
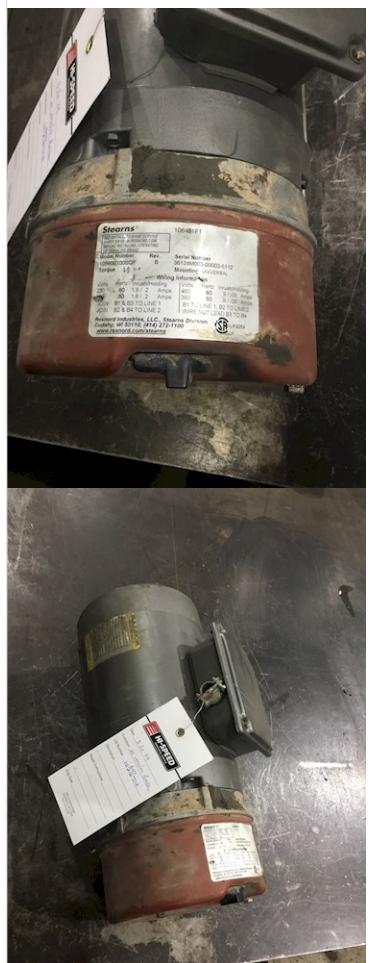
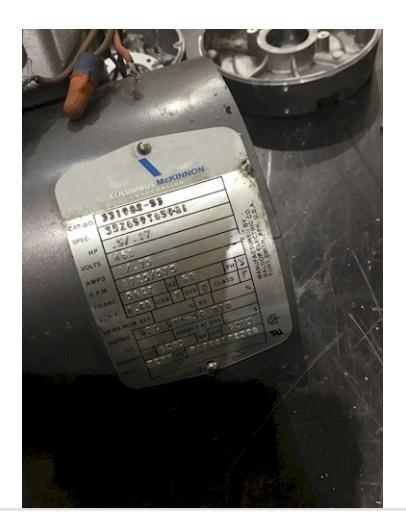
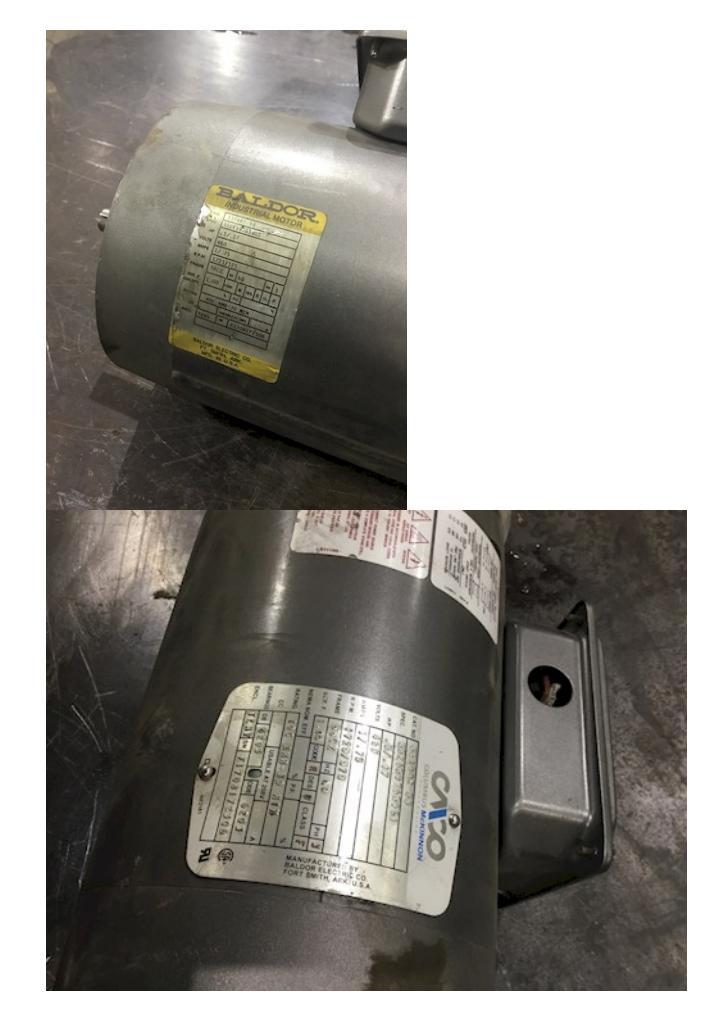
4.	4. Describe the Overall Condition of the Equipment as Received				
		Needs rewind and bearings				
In	itial I	Mechanical/Electrical				
	5.	Does Shaft Turn Freely?			(Y) Yes	
	6.	Does the shaft require T.I.R in La	the to identify additional repairs?		(No) No	
	7.	Does Shaft Have Visible Damage	?		(No) No	
	8.	Assembled Shaft Runout			0.001 Inches	
	9.	Assembled Shaft End Play			inches	
		Na				
	10.	Air Gap Variation <10%			n	
	•	Na				
	11.	Lead Condition			(P) Pass	
	12.	Lead Length			8 Inches	
	13.	Does it have Lugs?, If so what is	the Stud Size?		(No) No	
	14.	Lead Numbers			123 11 12 13	
	15.	Frame Condition			good	
	16.	Fan Condition			(P) Pass	
	17.	Broken or Missing Components			no	
In	Initial Electrical Inspection					
	18.	Insulation Resistance/Megger			0 Megohms	
	19.	Winding Resistance				
		1-2	1-3	2-3		
		0	0	0

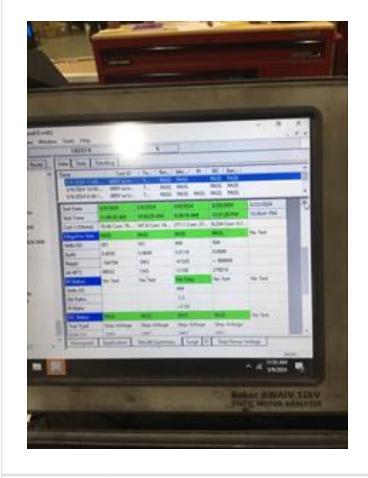
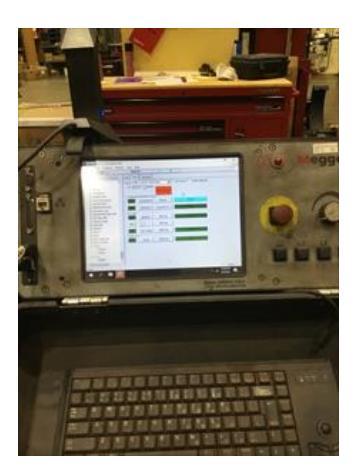
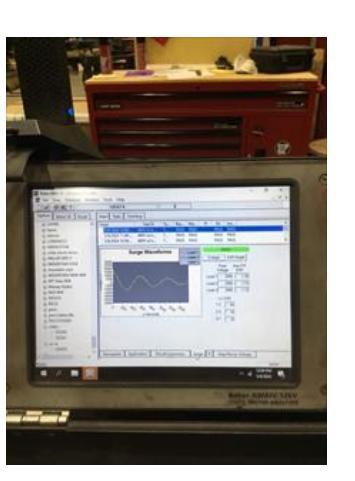
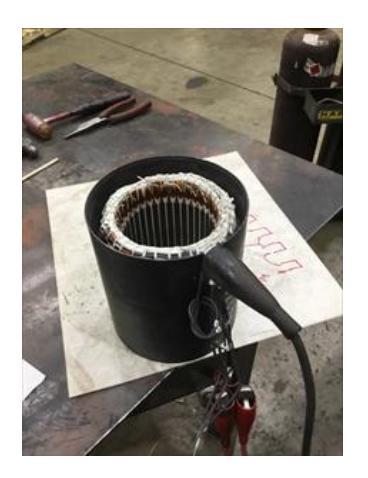
78. Post Rewind Hi-Pot

First test H speed. Second test L speed
