**DC Repair Report**

**Reynolds Metals company** 1333 highway 270

| DC Repair Rep | ort Rev. 2 | Hi-Speed Job Number: | 103786 | |
|---|---|---|---|--|
| Description:100HP GE 1750/2100 RPM | | Armature Voltage: | 500 (Volts) | |

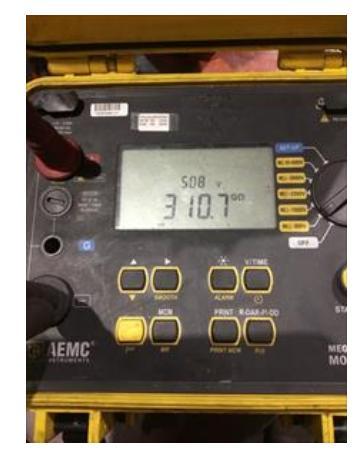
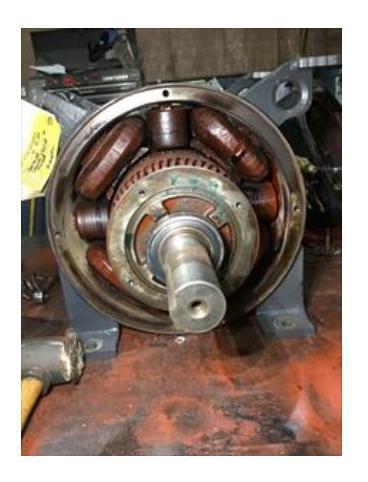
Brush holder to frame

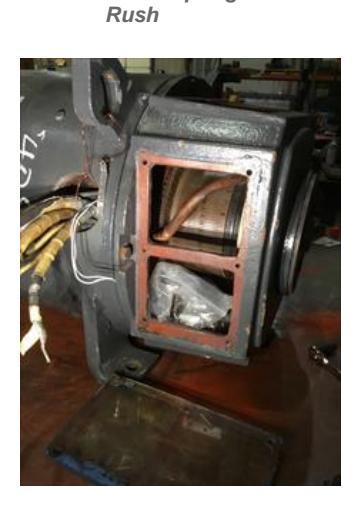
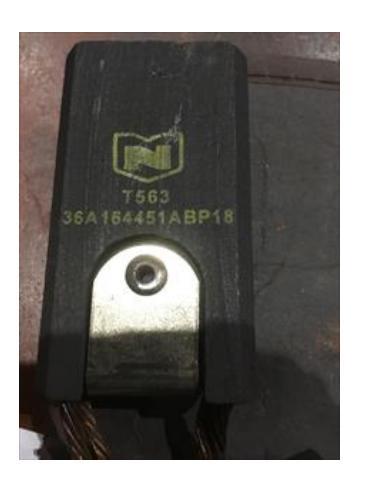
| | Brush springs and holders were re | moved from the motor and were in plas | tic bags inside the ODF housing |

14. Brush Holder Condition - Verify proper gap to Commutator
*Disconnected by previous technician.*

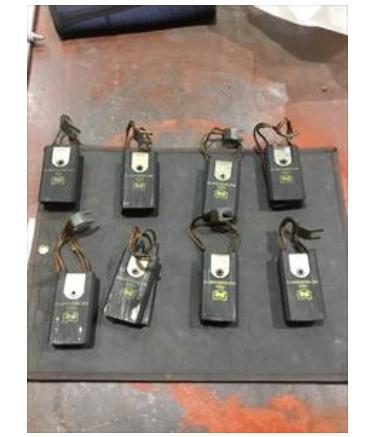
15. General Condition of the Armature/Commutator

brush holders serviceable

needs polished

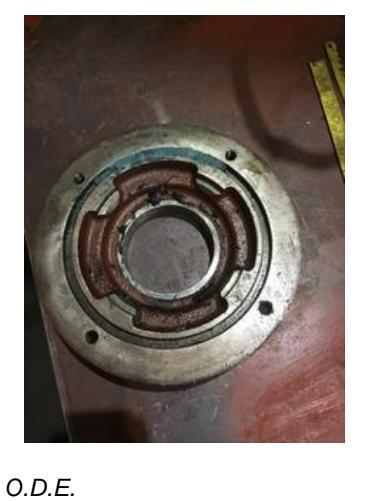
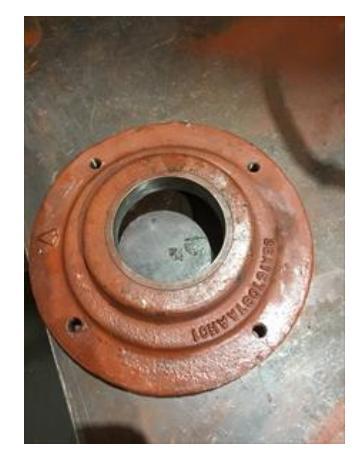
| N | Mechanical Fits- Bearing Housings | | | | |
|---|---|---|---|---|---|
| | • | Needs polishing. | | | |

0.D.E.

| D.E. | | D.E. | |

| D.E. | | D.E. | |
|---|---|--|---|
| | D.E housing fit needs polishin | g with course scotch-brite. Verified by macl | hinist |

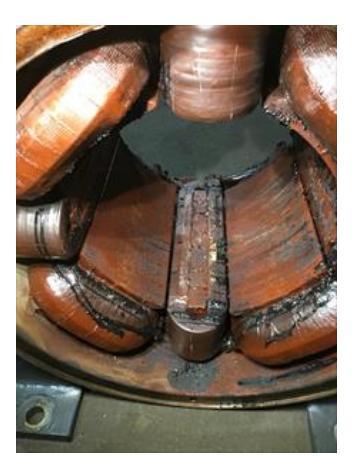
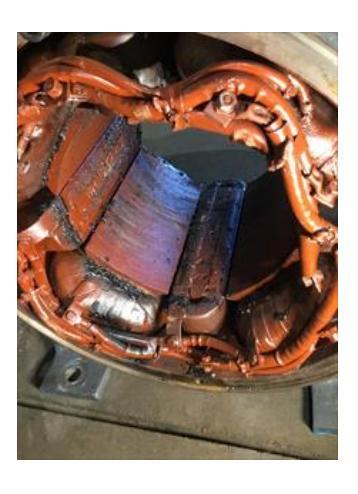
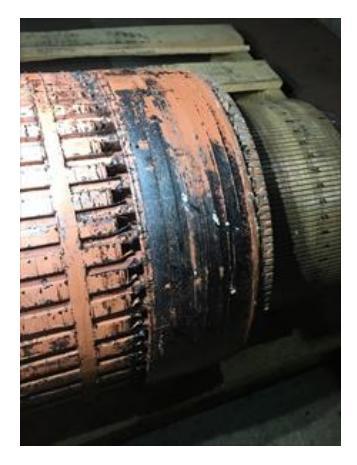
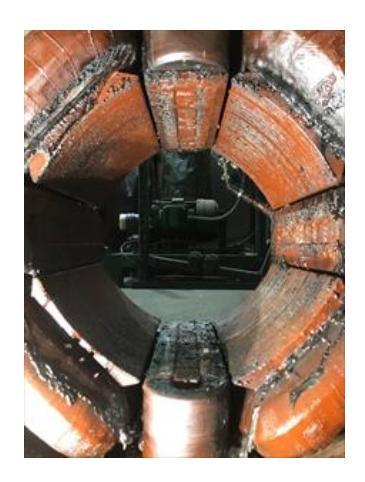
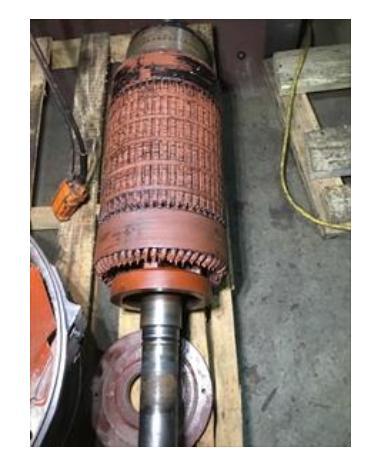
### 66. Failure Locations

Total rewind of fields and inter poles due to excessive amounts of heat generated which melted insulation inside the stator.
