AC Inspection as Found Process And Power 1721 Corporate Ave Memphis Tn, TN 38132

AC Inspection	on - Rev. 2	Hi-S
Location:	Shop	Man
Serial Numbe	Pro	
Description:200 HP AC Motor		HP/
		DDI

Hi-Speed Industrial Service
7030 Ryburn Dr
Millington, Tn 38053
901-873-5300

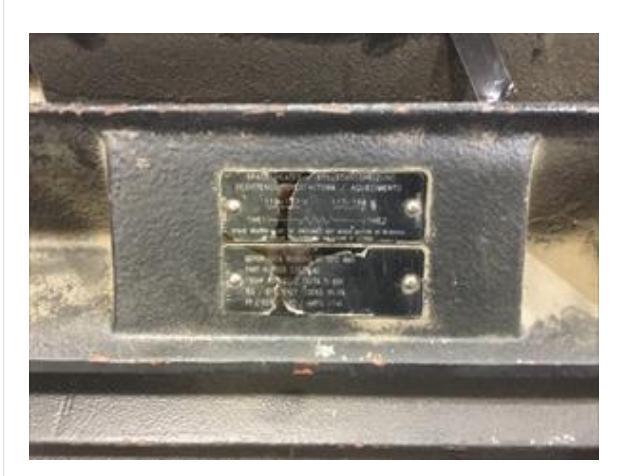
2. Nameplate Picture

Hi-Speed Job Number:	152819
Manufacturer:	WEG
Product Number:	23827140
HP/kW:	200 (HP)
RPM:	1785 (RPM)
Frame:	280S/M
Voltage:	460
Current:	228 (Amps)
Phase:	Three
Hz:	60 (Hz)
Service Factor:	1.21
Enclosure:	TEFC
# of Leads:	6
J-box Included:	Complete
Coupling/Sheave:	None
Date Received:	05/16/2024
Bearing RTDs:	No
Stator RTDs:	No
Repair Stage:	Teardown Inspection
Rewind:	No
Shaft Machined Fit Repairs Required:	No
Bearing Housing Machined Fit Repairs Required:	No
Heaters:	Yes
Winding Type :	Random Wound
Bearing Type:	Rolling Element

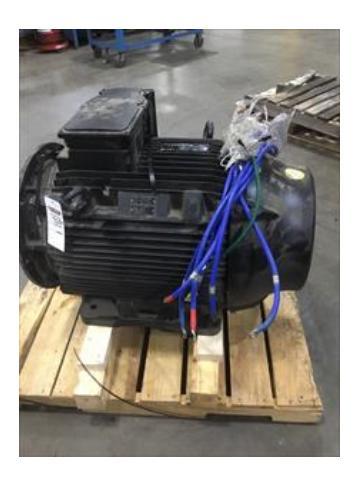
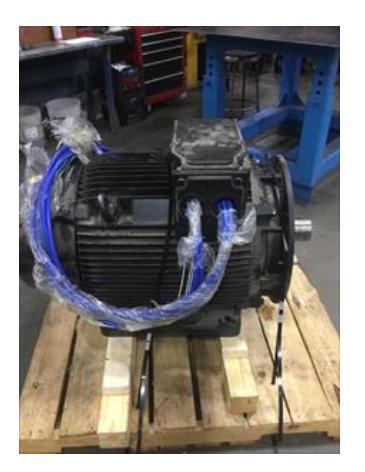
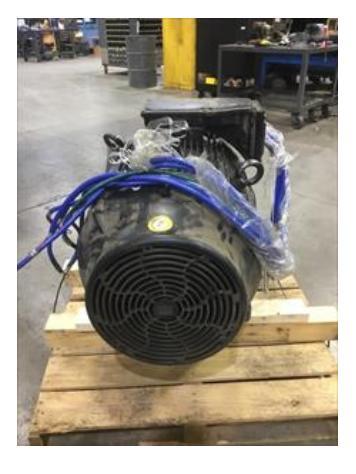
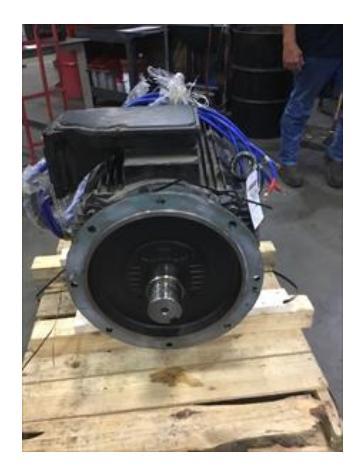
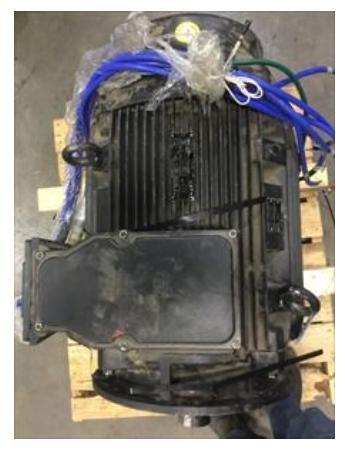
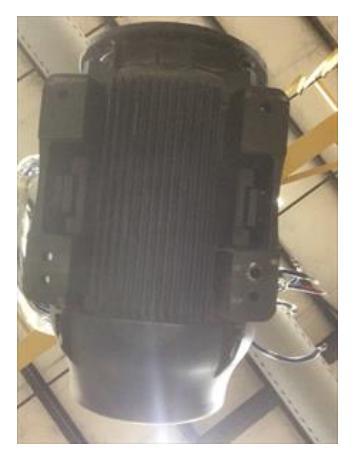
3. Photos of all six sides of the machine.

4.	Describe the Overall Condition of the Equipment as Received	Needs new bearings to recondition!	
Ini	itial I	Aechanical/Electrical	Needs new bearings to recondition:	0
	5.	Does Shaft Turn Freely?	(Y) Yes	
	6.	Does the shaft require T.I.R in Lathe to identify additional repairs?	(No) No	
	7.	Does Shaft Have Visible Damage?	(No) No	
	8.	Assembled Shaft Runout	0.008999999999999999999 Inches	
	9.	Assembled Shaft End Play	0.001 inches	
	10.	Air Gap Variation <10%	no provisions for measurement	
	11.	Lead Condition	(P) Pass	
	12.	Lead Length	78 Inches	P12

48. List the Parts needed for the Repair Below 6319 C3 6316 C3 VA 95

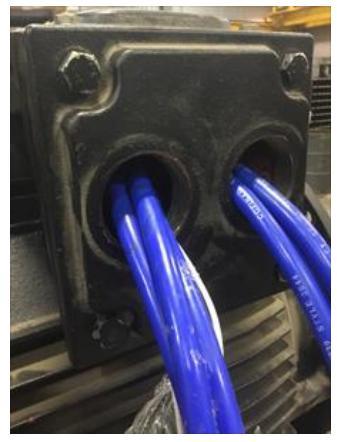
78" from edge of j box

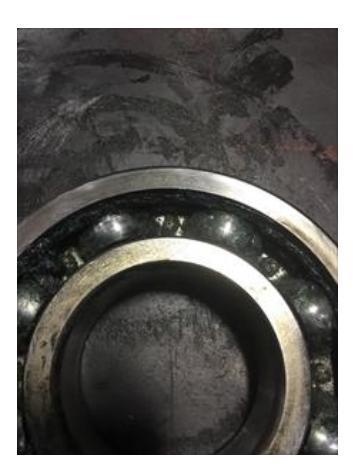
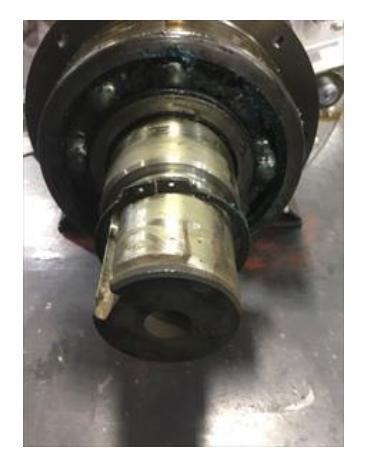
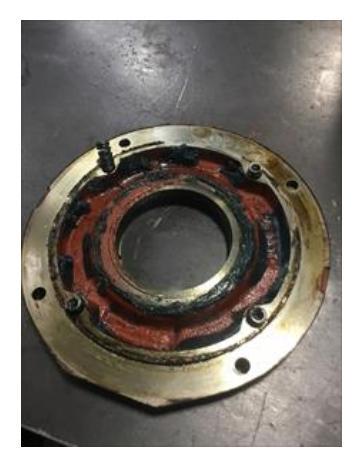
35. Opposite Drive End Bearing Number-

1	Opposite Drive End Bearing Qty.
	(Ball) Ball Bearing	7. Opposite Drive End Bearing Type
	(Grease) Grease Lubricated	 Opposite Drive End Lubrication Type
	none	Opposite Drive End Bearing Insulation or Grounding Device?
P40	springs/ snap ring	0. Opposite Drive End Wavy Washer/Snap-Ring Other Retention Device?

6316 C3

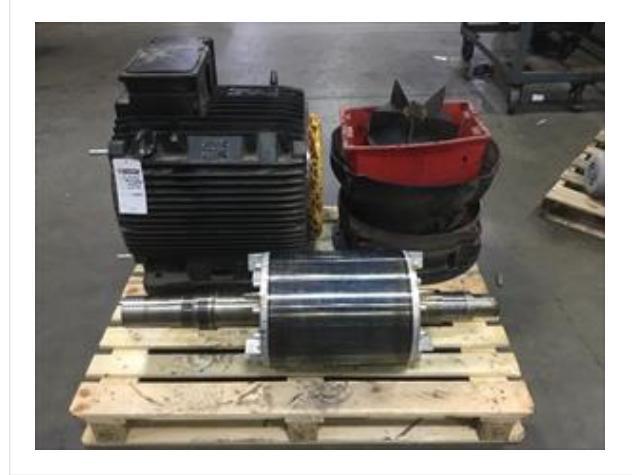
42.	Drive End Seal	VA 95	
43.	Opposite Drive End Seal	VA 80	
Rotor I	nspection		0
44.	Rotor Type/Material	(Squirrel Aluminum) Squirrel Cage Aluminum Die Cast	
45.	Growler Test	(Pass) Pass	
46.	Number of Rotor Bars	40	
47.	Rotor Condition	Pass	P47
