AC Inspection as Found Arkansas Electric Cooperative (12029)

AC Inspection - Rev. 2

Location:	LR Motor Shop
Serial Number:	2003

Description:2250HP HITACHI 505RPM

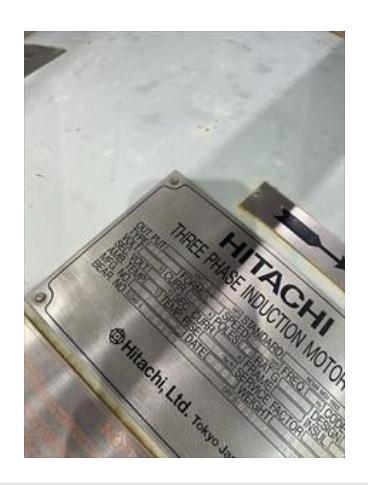
2. Nameplate Picture

Hi-Speed Job Number:	103320
Manufacturer:	Other
Product Number:	M: 377468-2
Serial Number:	2003
HP/kW:	2250 (HP)
RPM:	505 (RPM)
Frame:	VERTICAL
Voltage:	6600
Current:	185 (Amps)
Phase:	Three
Hz:	60 (Hz)
Service Factor:	1.15
Enclosure:	WPI
# of Leads:	3
J-box Included:	Complete
Coupling/Sheave:	Coupling
Bearing RTDs:	Yes
Stator RTDs:	Yes
Repair Stage:	Final
Rewind:	No
Shaft Machined Fit Repairs Required:	No
Bearing Housing Machined Fit Repairs Required:	No
Heaters:	Yes
Winding Type :	Form Coil
Bearing Type:	Rolling Element

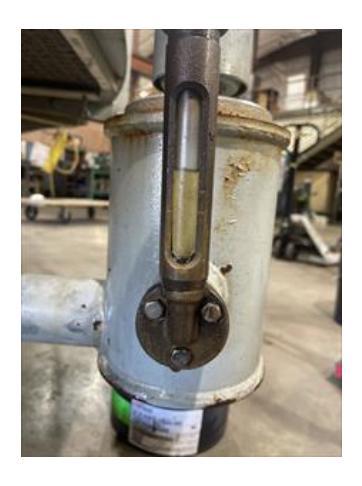
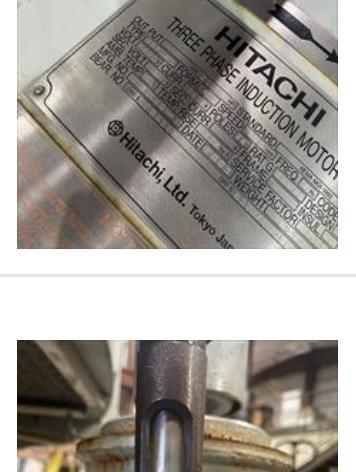
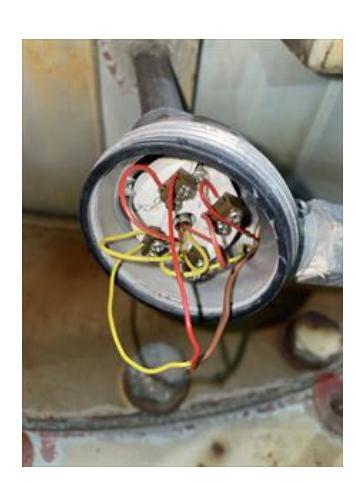
3. Photos of all six sides of the machine.

- Describe the Overall Condition of the Equipment as Received Motor is dirty inside and needs bearings replaced. Rotor was packed with dirt. Stator had a lot of trash behind the laminations.
- 5. Distance from the end of the shaft to the Coupling/Sheave

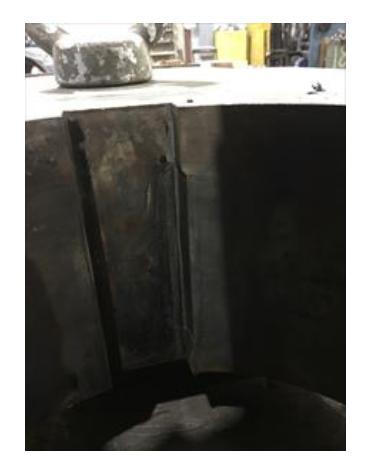
Machined new key.

67.	End Bell Air Seal Fits			
		Drive End Air Seal	Opposite Drive End Air Seal		
		good	good		
	68.	List Machine Work Needed Below			
		Make a new key and fix where key g	joes into shaft.

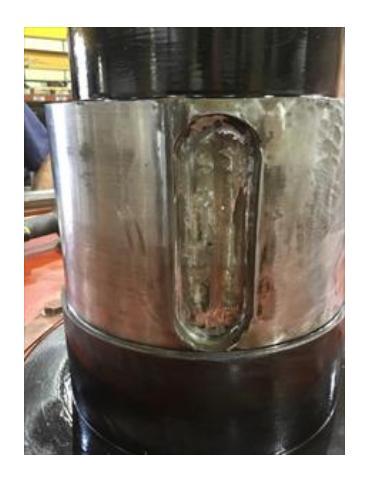
Removed gaulding from keyseat.

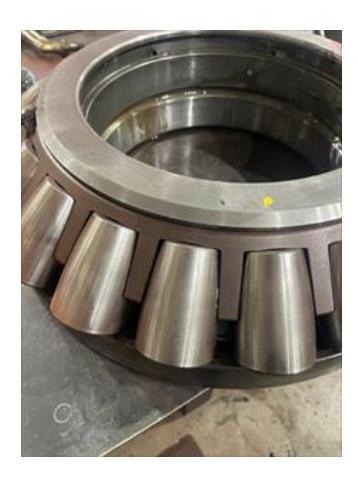
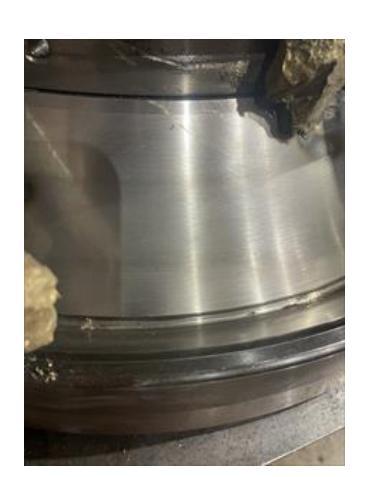
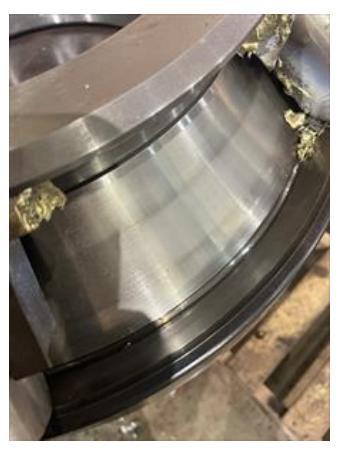
36. Drive End Bearing Condition

37.	Opposite Drive End Bearing Brand	NSK	
38.	Opposite Drive End Bearing Number-	6332 c3	P100
39.	Opposite Drive End Bearing Qty.	1	
40.	Opposite Drive End Bearing Type	(Ball) Ball Bearing	
41.	Opposite Drive End Lubrication Type	(Grease) Grease Lubricated	
42.	Opposite Drive End Bearing Insulation or Grounding Device?	no	
43.	Opposite Drive End Wavy Washer/Snap-Ring Other Retention Device?	retaining nut and washer	
44.	Opposite Drive End Bearing Condition	worn	P119
•	Bearing shows signs of a bad check valve allowing the upper end to hammer. hammering.	Bearing has pitting from

69.	Technician		Trevor Hall	
	/				
		Infil			
R	oot C	ause of Failure			
	70.	Failure locations			
		Bearings, key, keyway and debris b	uildup inside motor.

71.	Root cause of failure			
		Normal wear and hammering of the	antiratchet device. Buildup of material	inside motor.	_
D	ynam	ic Balance Report			0

45.	Drive End Seal			
46	Opposite Drive End Seal			
т 0.	Na			
Rotor	Inspection			
47.	Rotor Type/Material		(Copper Barred) Copper Barred Rotor	
48.	Growler Test		(Pass) Pass	
49.	Number of Rotor Bars		136	
50.	Rotor Condition		Good	
51.	List the Parts needed for the Re	pair Below		
	6332 c3 bearing FJ-6 29456			
52.		assembled Motor	Trevor Hall	
Mecha	anical Fits- Rotor			
53.	Shaft Runout		0.001 inches	
54.	Rotor Runout	Deter De l		
	Drive End Bearing Fit		Opposite Drive End Bearing	
55	Coupling Fit Closest to Bearing	Housing	0.002	
00.	0 Degrees	90 Degrees	120 Degrees	
	0 209.000	00 203.000	.20 209.000	
•	Pass			
56.	Coupling Fit Closest to the end of	of the Shaft		
	0 Degrees	60 Degrees	120 Degrees	
	Pass			
57.	Drive End Bearing Shaft Fit			
	0 Degrees	60 Degrees	120 Degrees	
	11.0245	11.0245	11.0246	
58.	Drive End Bearing Shaft Fit Con	dition	(P) Pass
