AC Inspection as Found Welspun Tubular (11685) 9301 Frazier Pike

AC Inspect	ion - Rev. 2		Hi-Speed Job Number:	104111
Location:	LR MOTOR S	SHOP	Manufacturer:	Siemens
Serial Numb	er: N8/64L4L270		Product Number:	LLAO224-4YA96-Z
Description:	45 KW SIEMANS		Spec/ID #:	IEC 60034-1
			Serial Number:	N8/64L4L270
			HP/kW:	45 (HP)
			RPM:	1776 (RPM)
			Frame:	225M
			Voltage:	460
			Current:	70 (Amps)
			Phase:	Three
			Hz:	60 (Hz)
			Enclosure:	TEFC
			# of Leads:	6
			J-box Included:	Complete
			Coupling/Sheave:	None
			Date Received:	02/06/2025
			Bearing RTDs:	No
			Stator RTDs:	No
			Repair Stage:	Final
			Rewind:	Yes
			Shaft Machined Fit Repairs Required:	Yes
			Bearing Housing Machined Fit Repairs Required:	Yes
			Heaters:	No
			Winding Type :	Random Wound
			Bearing Type:	Rolling Element
Priorities Found	: 🛑 10 - High	🔵 6 - Good

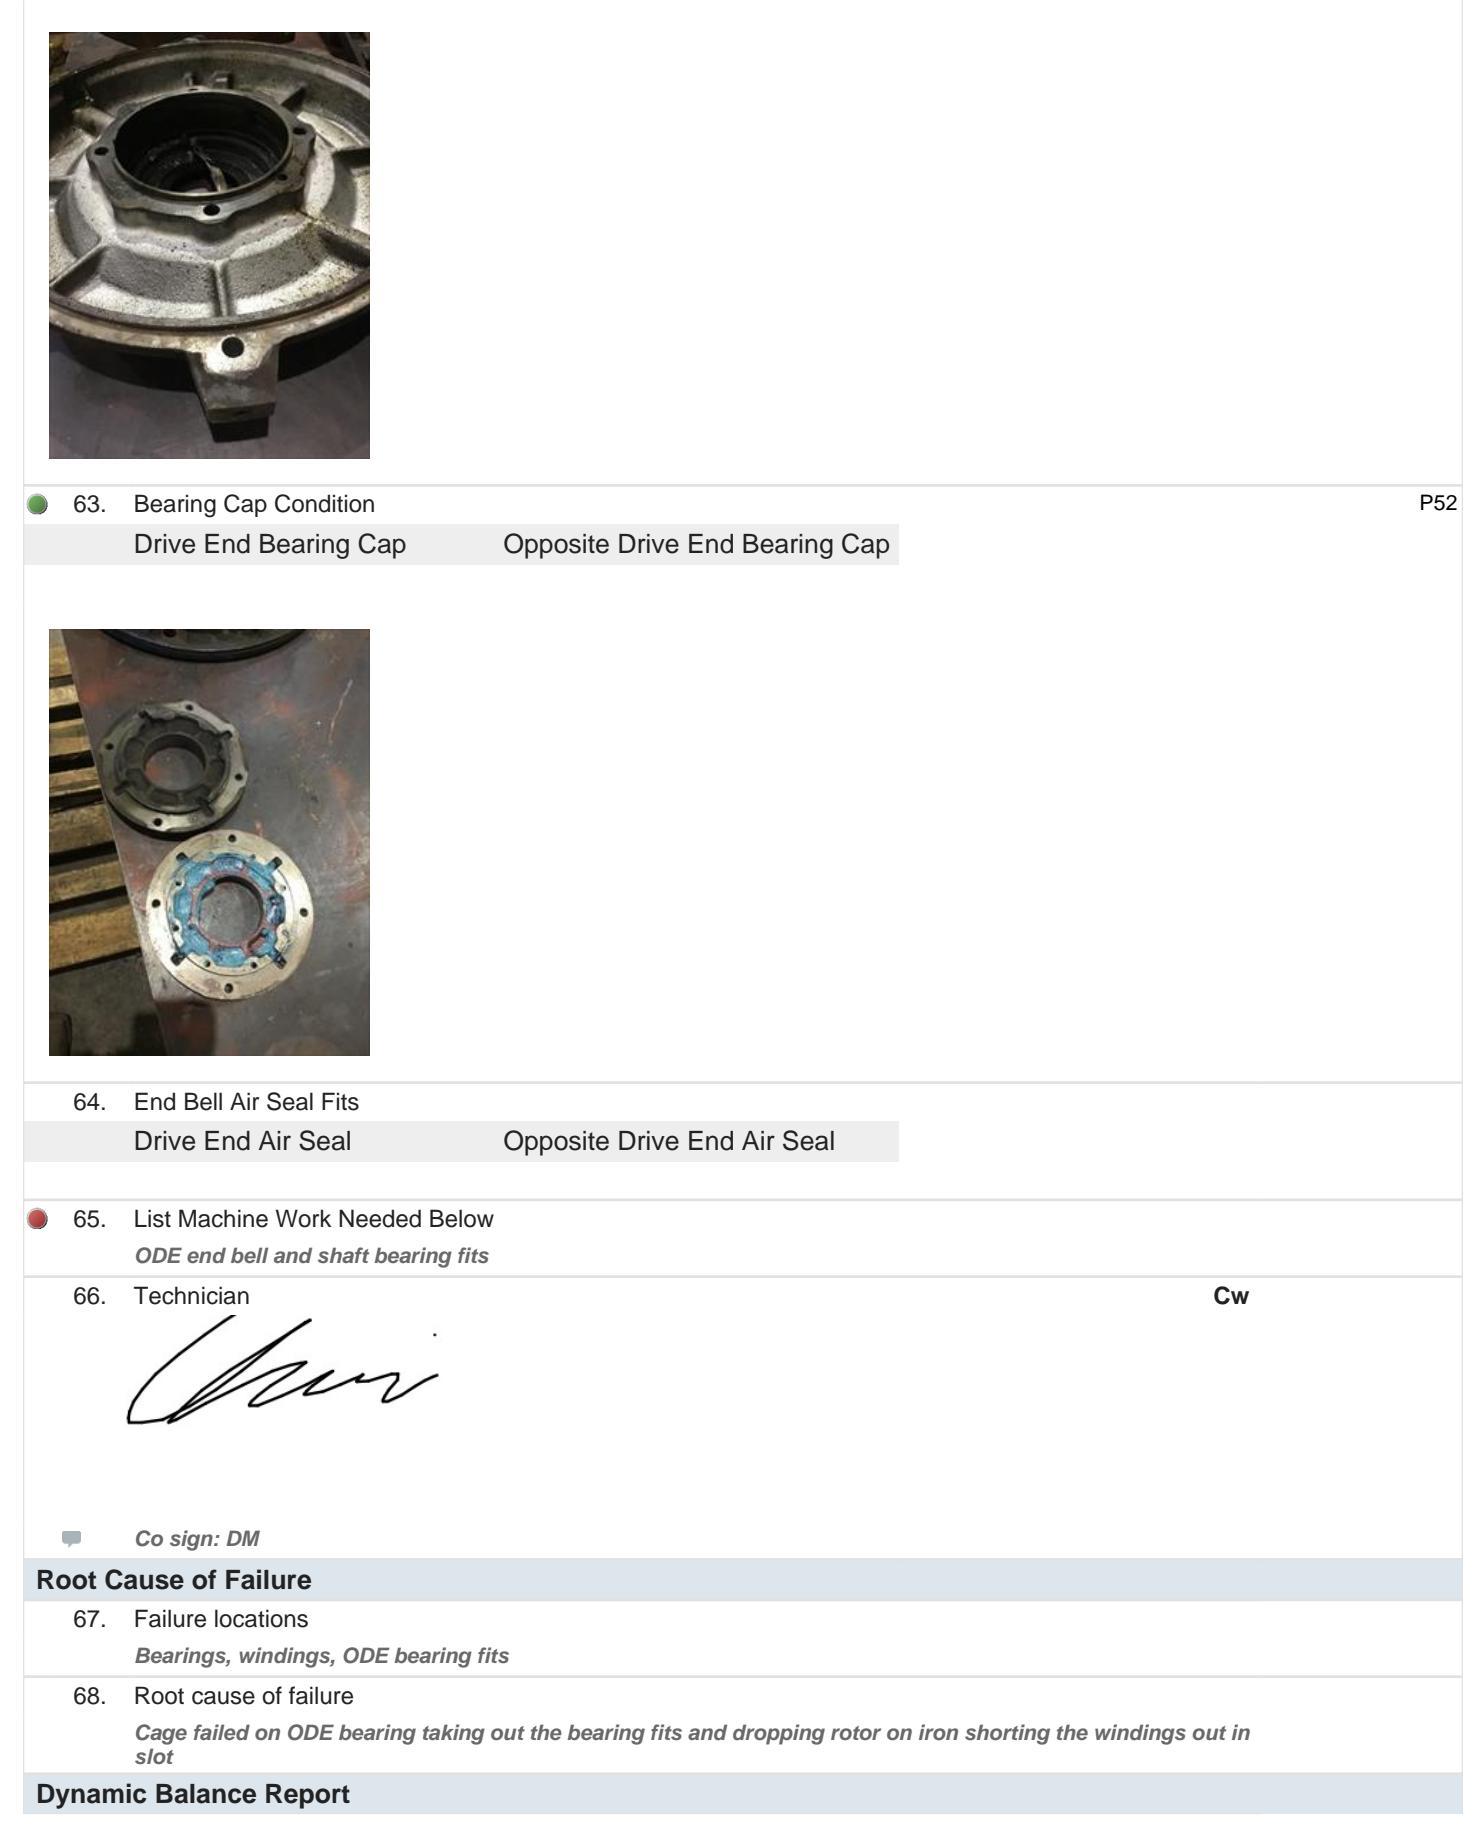
56.	Opposite Drive End Bearing Shaf	t Fit		P89
		0 Degrees	60 Degrees	120 Degrees	
	57.	Opposite Drive End Bearing Shaf	t Fit Condition	(F) F	ail P95
	-	Bearing spun on shaft			
	59	Shaft Air Saal Fita			
	58.	Shaft Air Seal Fits	Opposite Drive End Air Seel		
		Drive Eriu Ali Seal	Opposite Drive Ellu All Seal		
Μ	echa	nical Fits- Bearing Housings			0
	59.	Drive End - Endbell Bearing Fit			
		0 Degrees	60 Degrees	120 Degrees	
	-	2.5599-2.5599-2.5599			
	60.	Drive End - Endbell Bearing Fit C	ondition	(P) Pa	SS
	61.	Opposite Drive End - Endbell Bea	ring Fit		
		0 Degrees	60 Degrees	120 Degrees	
		Excessive wear and sleeve is pulle	d out
