The following is a summary of findings from the vibration analysis on the ID Fan/Gearbox and the SM1 Feed Tank Agitator Drive that was performed on 1/21/25.

ID Fan CLASS III

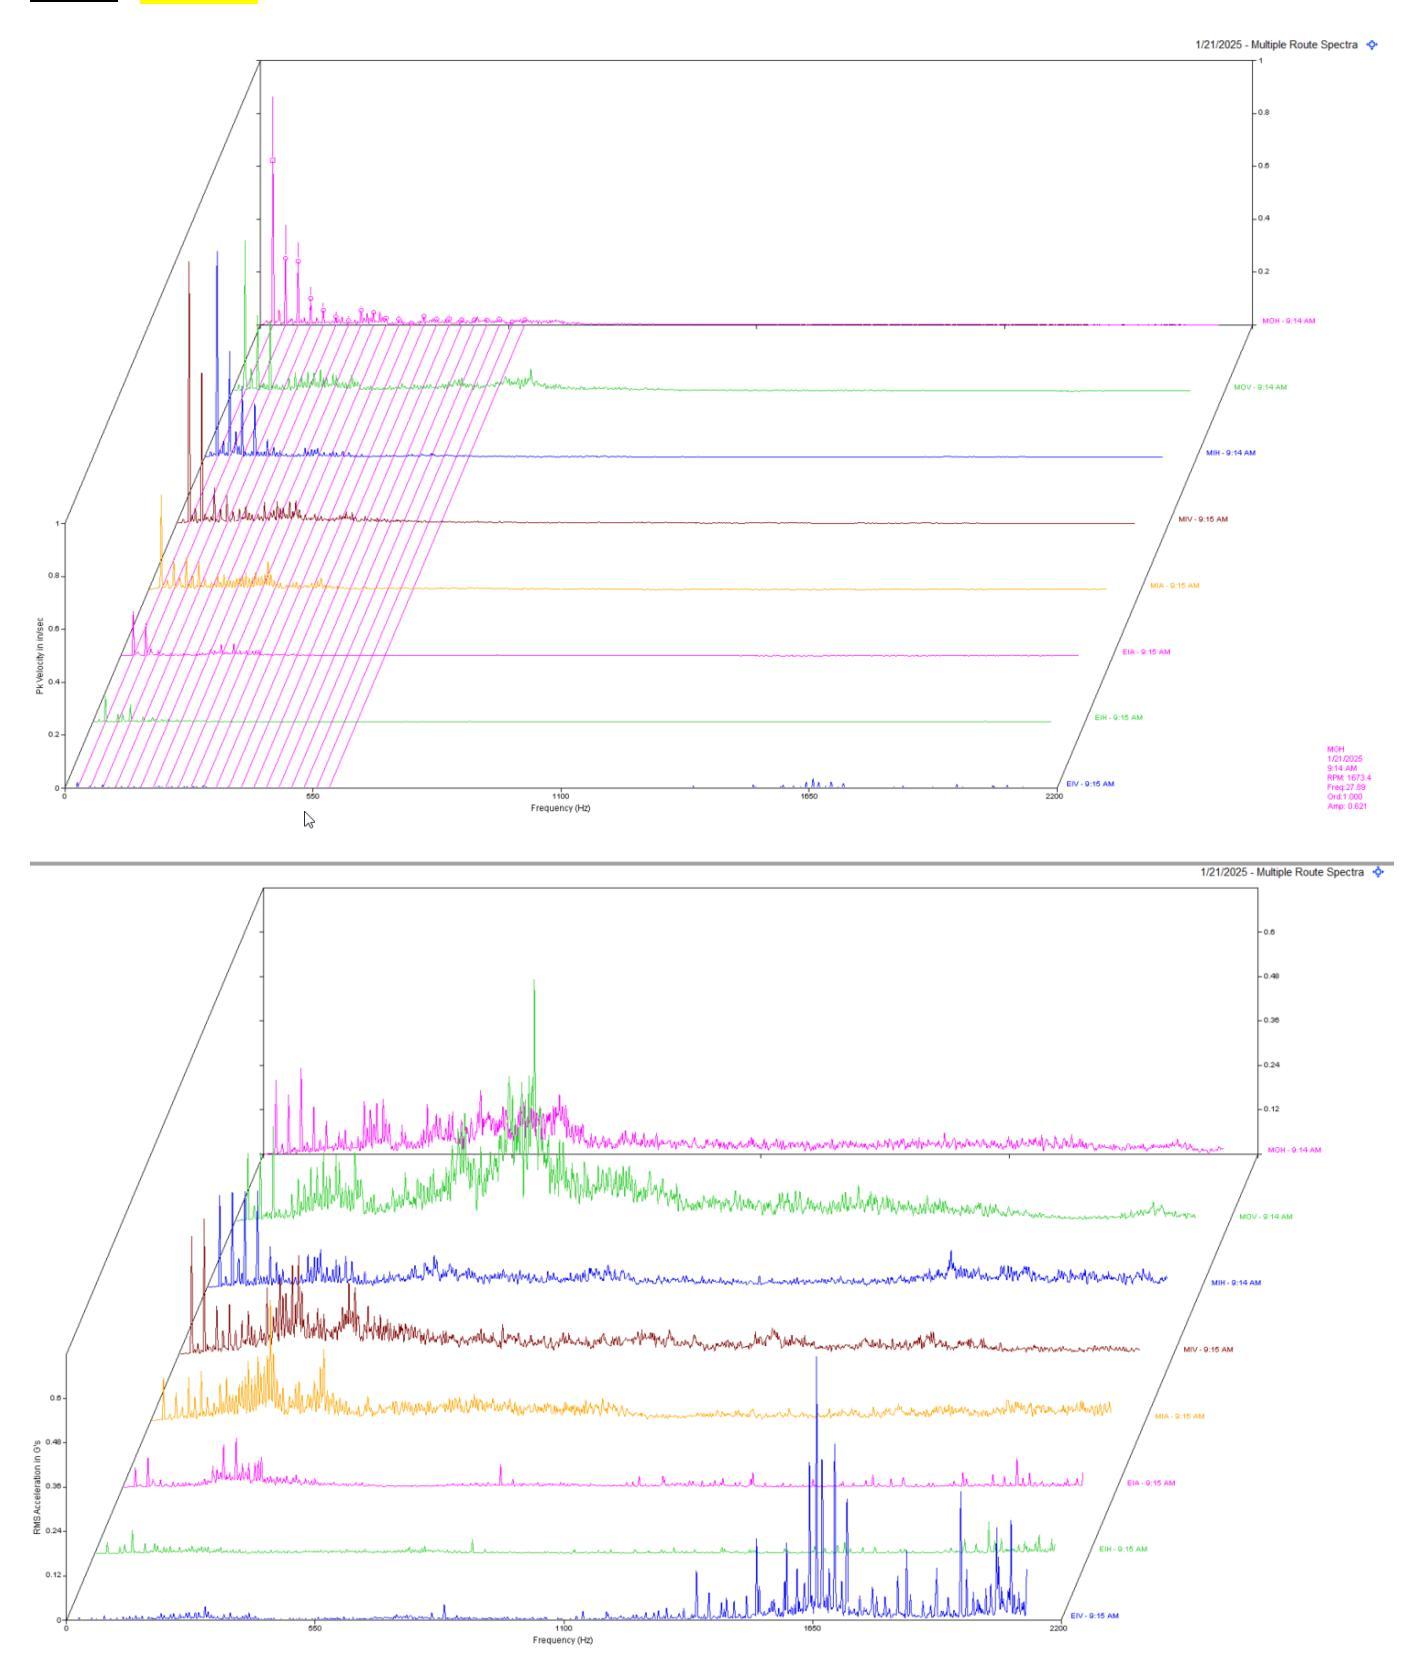
Observation:

Waterfall velocity spectra above (TOP DATA PLOT) is the fan and the gear box. MOH-MIA are the fan points. EIA-EIV are the gearbox points. Data shows quite a bit of rpm harmonic vibration in the fan (MOH-MIA). This is indicative of mechanical looseness. Gearbox velocity data appears to be much lower in amplitude than the fan. The second plot shows the same data points in acceleration. Notice that EIV which is Gearbox DE vertical shows some high frequency vibration. Some of these peaks appear to be non-synchronous, which indicates possible defects within the bearing. This appears to be minor at this time as there is very little velocity amplitude.

Recommendation:

The fan has excessive vibration. A lift check of the fan shaft using a dial indicator should be performed. There may be wear of the fan bearing/housing/shafts fits. The fan wheel and fan hub should also be inspected for cracks if possible. Also check fan shaft run-out using a dial indicator. Also, check couplings for visible defects/wear and ensure couplings are greased properly.

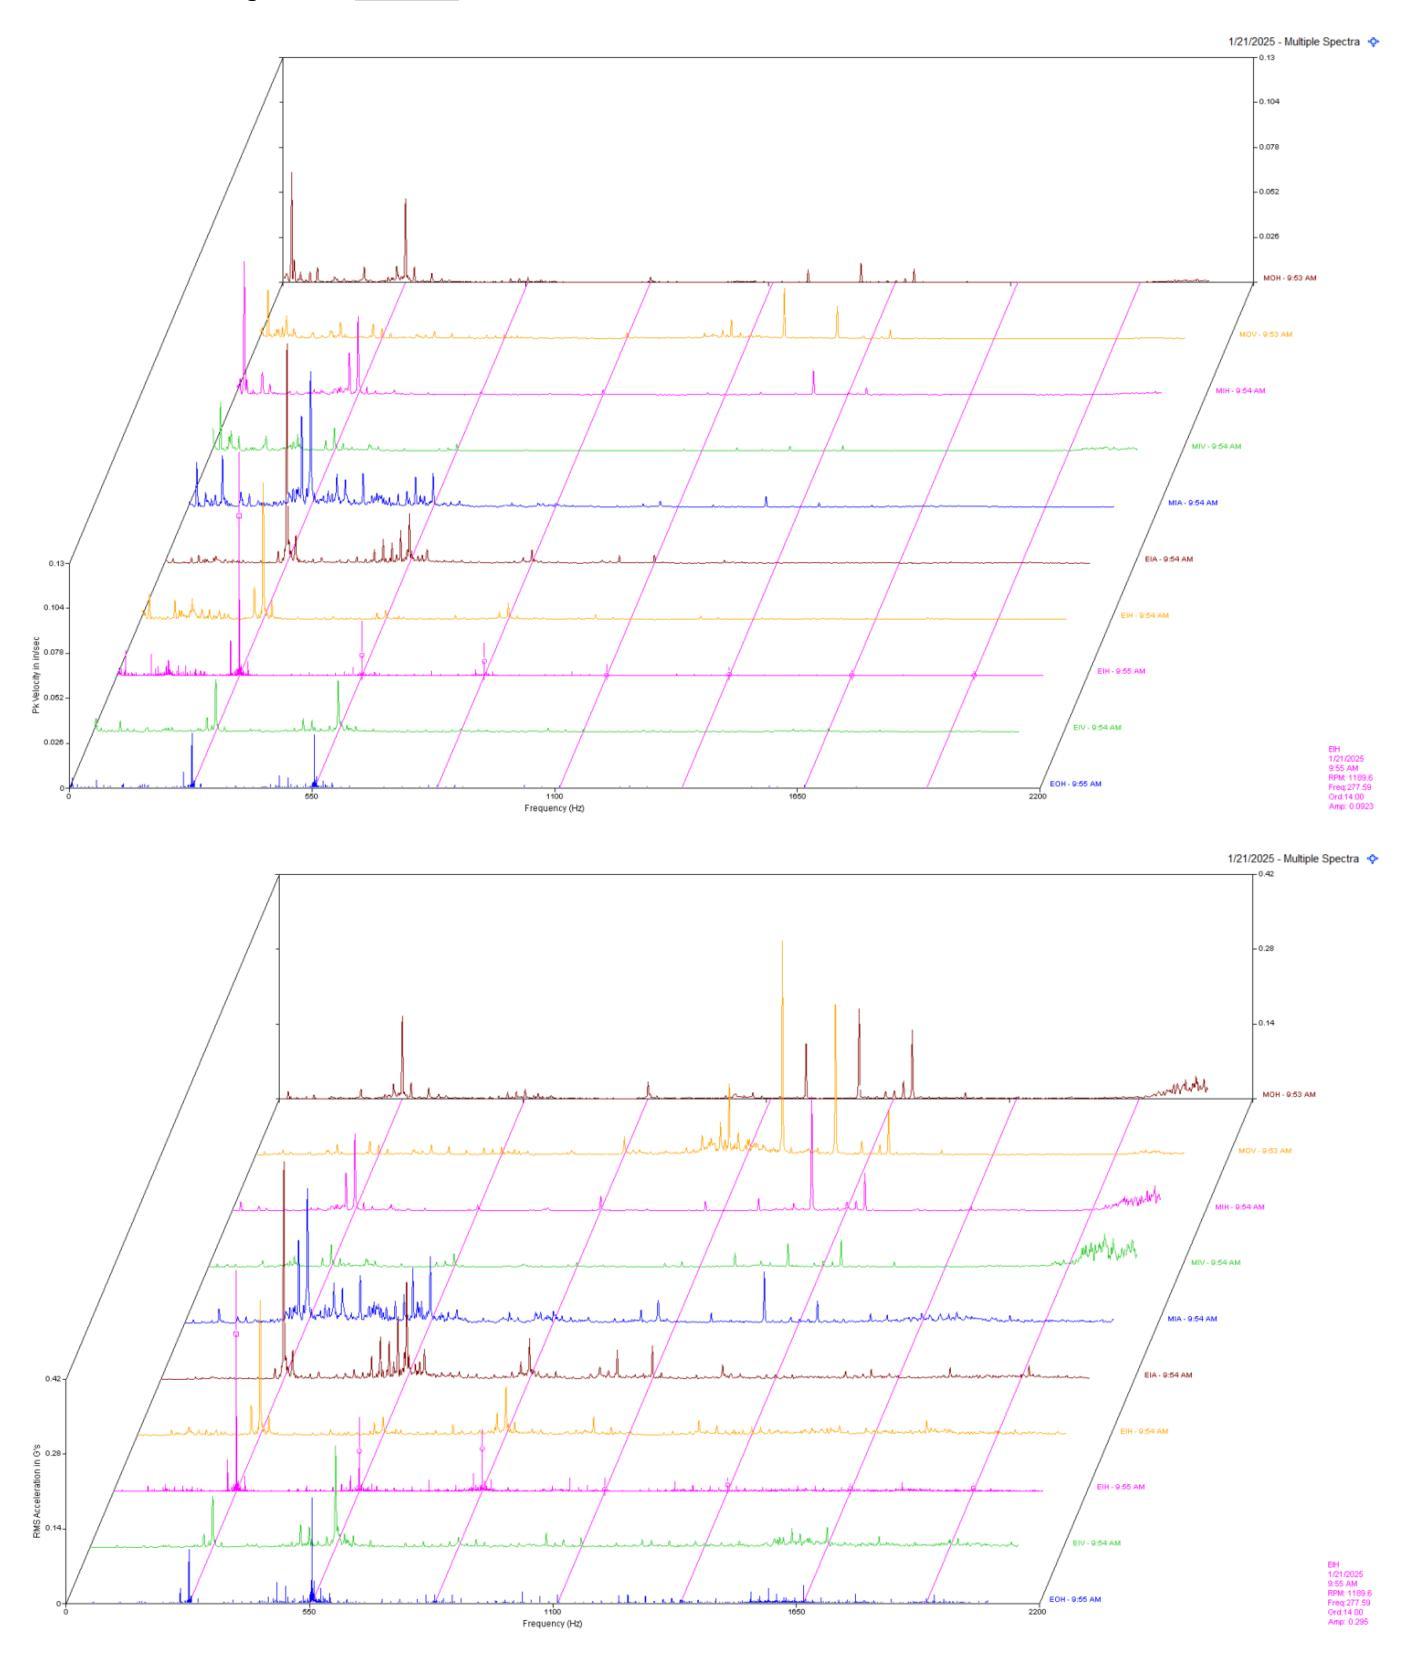
Observation:

Waterfall velocity spectra above (TOP DATA PLOT) is the motor and the gear box. MOH-MIA are the motor points. EIA-EIV are the gearbox points. Second plot are the same points in acceleration. There appears to be some gear mesh vibration according to spectral data. The first large peak in the EIA spectra is 14 x rpm. This is likely the gear mesh fundamental if the pinion gear has 14 teeth. There are also a first, second, and third harmonic of GMF. 2 x GMF appears to be dominant in the outboard end of the gearbox. This type of vibration typically indicates some wear and or internal misalignment of the gears. Amplitudes aren't very high, so severity is low at this time. Motor acceleration spectral data shows some peaks in higher frequency range. These peaks appear to be electrically related and are not really an issue here.

Recommendation:

Check gearbox oil and pull an oil sample if possible.
