Infrared Thermography Report

ESSEX POWER PLANT

November 23, 2020

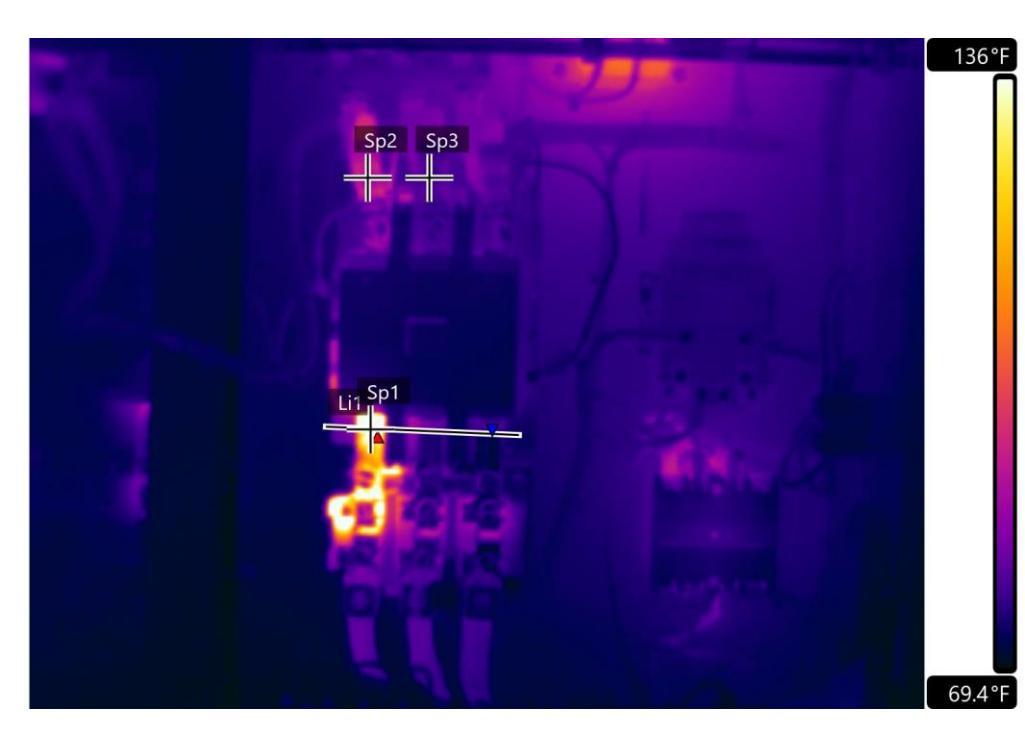
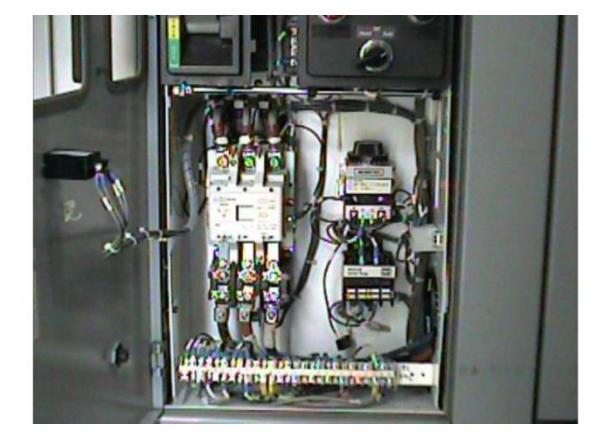
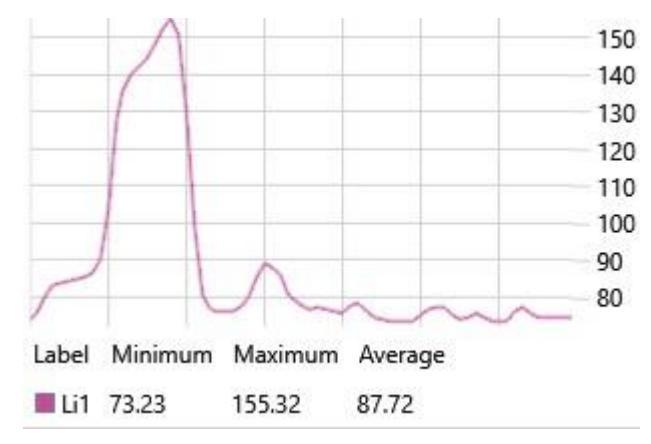
Component	Starter/Heater
Equipment/Bucket ID	Lube oil pump 2

Sp1	148.1 °F
Sp2	89.6 °F
Sp3	79.3 °F
Li1 Minimum	73.2 °F
Li1 Maximum	155.3 °F
Areas	-

Fault	A phase contact heater and connection.
Defect Rating	Class II

The A phase has a very high delta compared to the other legs in the starter. We suspect either a worn main contact in the starter, or a loose lug connection at the heater top. Inspect the starter and all contacts. Repair or replace as needed to control the temperature. Repair as soon as possible.
