Sales Gas Stage 1 Compressor Skid Motion Amplification Study, South Shelby RNG Memphis, TN

Hi-Speed Industrial Service was called in to use its Motion Amplification Technology to inspect the Sales Gas Stage 1 at South Shelby RNG in Memphis. TN. Vibration data of this unit does show some elevated 1 x rpm vibration in the vertical position. Therefore, Motion Amplification was used to help determine where and how much the motor/compressor base is flexing.

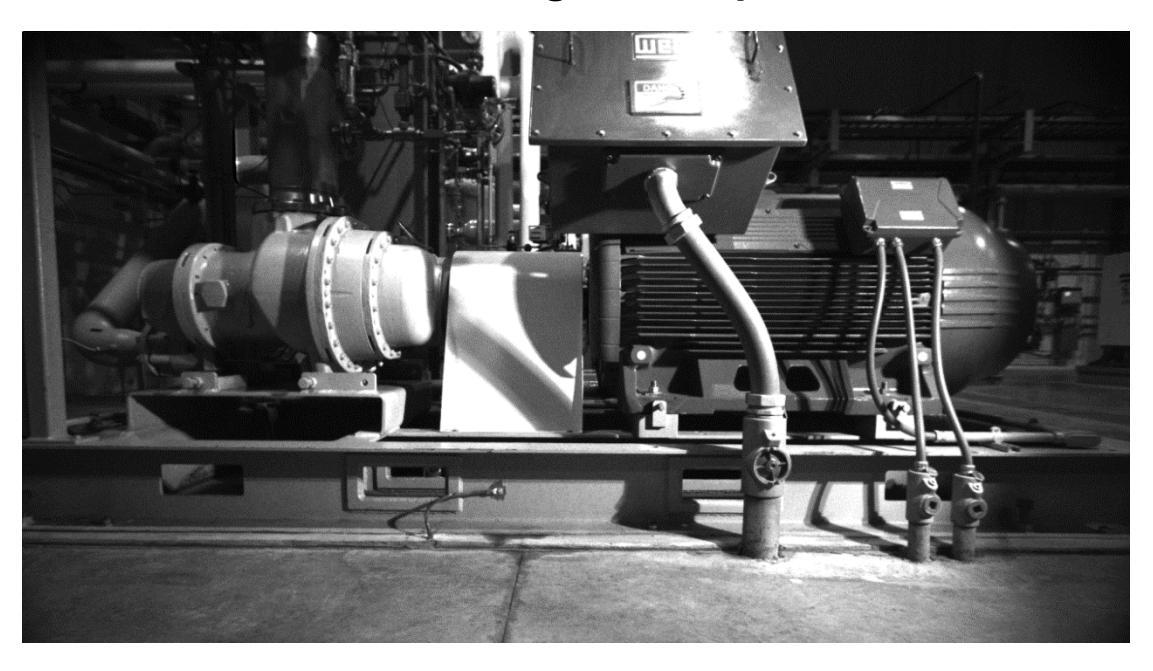
Figure 1: Motion Amplification, Side view Motor/Compressor

Motion amplification video of Sales Gas Stage 1 shows some movement especially under the compressor. This issue does not seem to be as severe as the Feed Compressors, likely because this compressor is smaller by design. It is still recommended to perform the modifications as planned. This will help alleviate unwanted forcing frequencies of vibration.

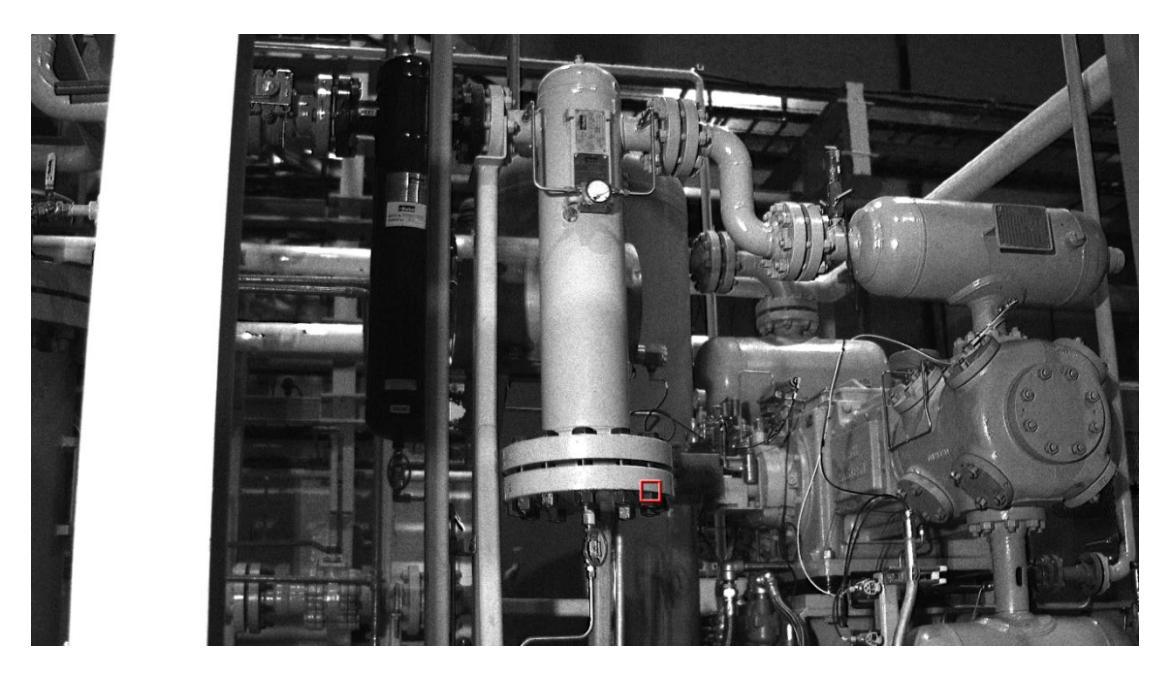
Figure 5: Motion Amplification, Sales Gas Stage 2 Piping, Filter housing, part of compressor

We also shot some video of Sales Gas Stage 2. We already know there is movement in several components of this unit, but MA video really shows this well. Basically, everything is vibrating at 1 x and/or 2 x compressor rpm. A ROI (region of interest) was drawn at the bottom of the filter assembly to collect vibration data from the image. Spectral amplitude shows nearly 1,0 ips-pk vibration in the x (horizontal axis) and Y (vertical axis).

We suspect some resonance is occurring in this unit. Further vibration analysis and perhaps Motion Amplification should be performed with the compressor operating at different rpms.
