IR\_1940.jpg S60 NTSC 21801575

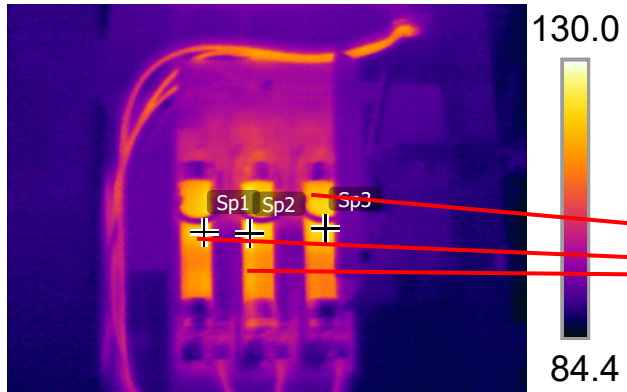
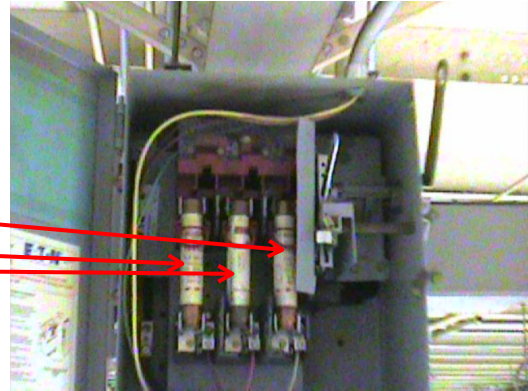
| Sp1 | 123.1 °F |
| Sp2 | 126.5 °F |
| Sp3 | 122.9 °F |

Infrared data indicates that All 3 fuses is operating at higher than normal temperatures. Replace all 3 fuses and clean fuse holders.
