IR\_1936.jpg S60 NTSC 21801575

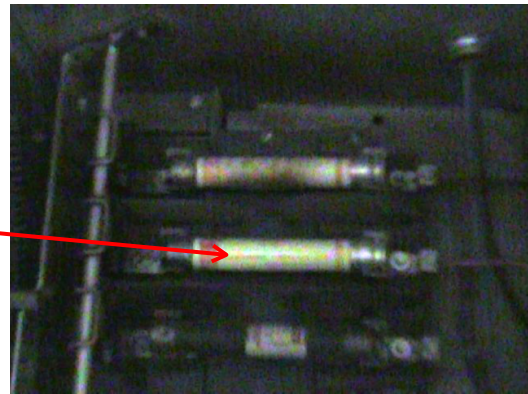
Sp1	102.3 °F
Sp2	87.0 °F

Infrared data indicates that Phase B fuse is operating at 20\* higher than phase A and C . Clean fuse holder and replace all 3 fuses with matching fuse brand and amprage ratings .
