IR\_1919.jpg S60 NTSC 21801575

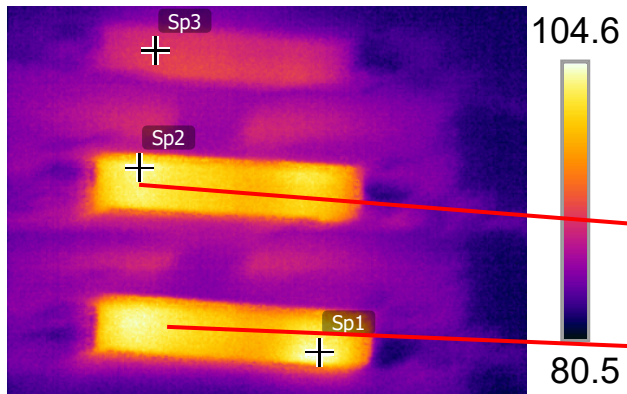
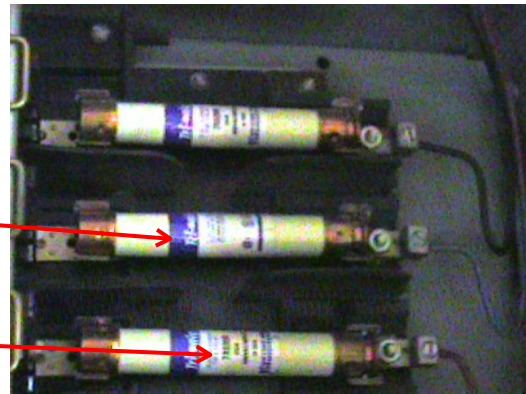
| Sp1 | 103.3 °F |
| Sp2 | 102.6 °F |
| Sp3 | 91.7 °F |

Infrared data indicates that phase B and C is operating 10\* higher . Clean fuse holders and replace all 3 fuses.
