AC Recondition As Found

Sage V Foods

AC Recondition - Rev. 2

Description: 2.5HP MIDWESTERN SHAKER
1200RPM

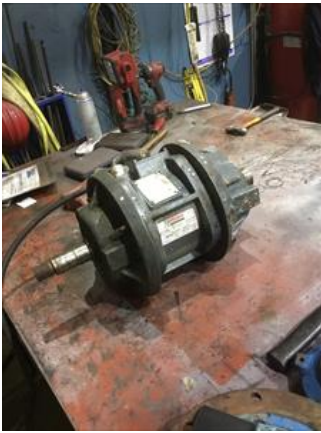
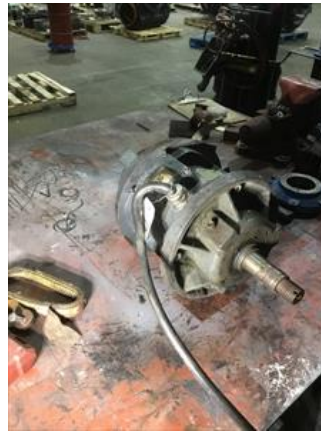
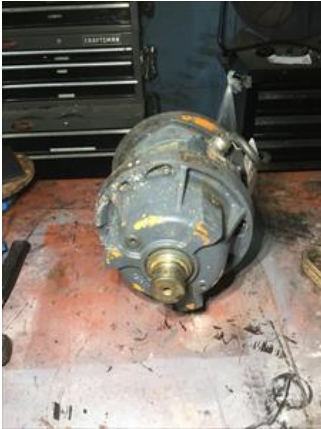
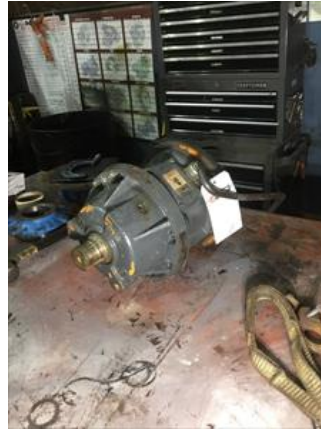
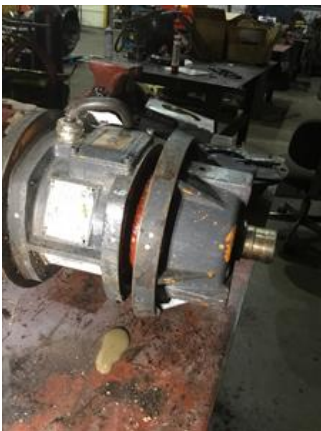
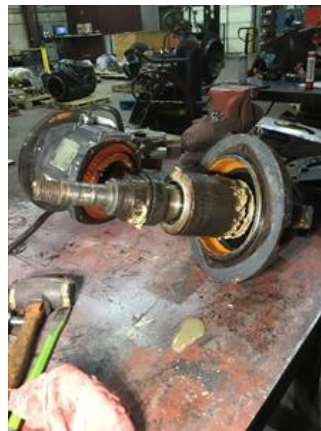
3. Photos of all six sides of the machine.

4. Describe the Overall Condition of the Equipment as Received
Dirty but serviceable.

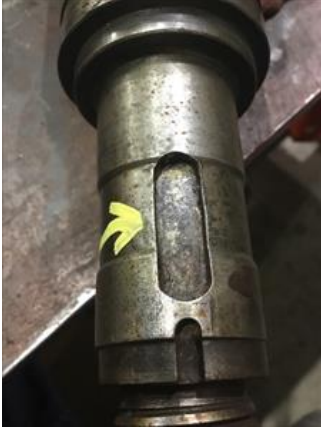
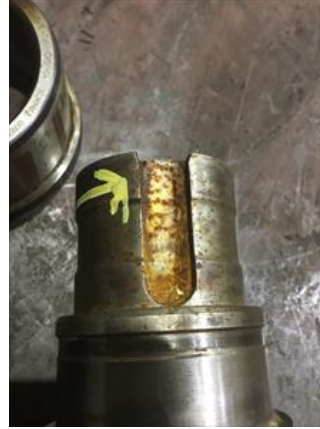
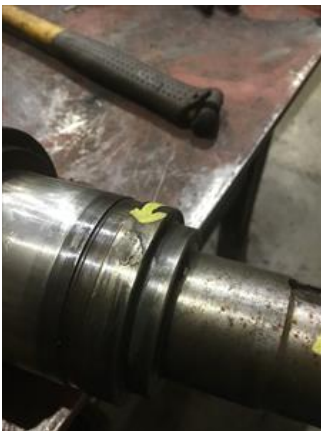
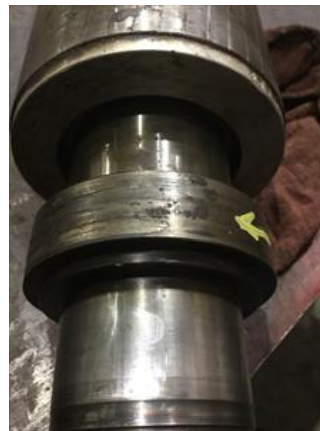
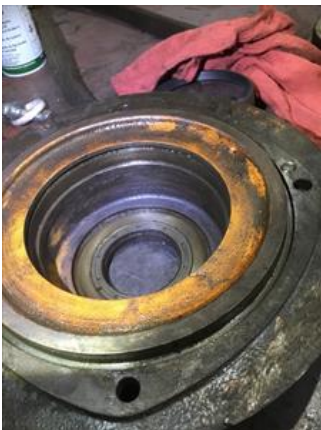
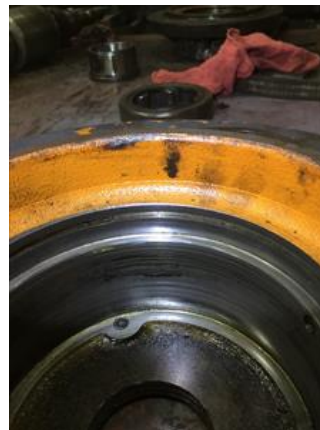
71. List Machine Work Needed Below

| 54. | List the Parts needed for the Repair Below <i>Both key ways wallowed. Both seal surfaces worn. Both housing fits need re-sleeved.</i> | | |
| | Excessive wear. | | |

Both key ways wallowed. Both housing fits bad. Both seal surfaces bad on screw side of rotor

| | Excessive wear. Re-sleeve | | |
| | Resleeve housing fit.- | | |
