Balancing Report

1. Job Number	104326
2. Report Date	03/20/2025
3. Customer	Nucor Memphis

3. Make
4. Model
5. Serial Number
6. Customer Asset ID/Asset Name **main bag house fan #4**

7. Service Objectives
Balance fan, check vibration. Provide report
8. Services Performed
Balance on main bag house fan
9. Service Technician Recommendations

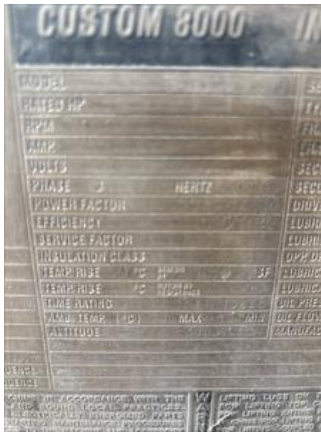
4. Balance Type	single plane-dynamic
5. Balance Operating Speed	893 RPM

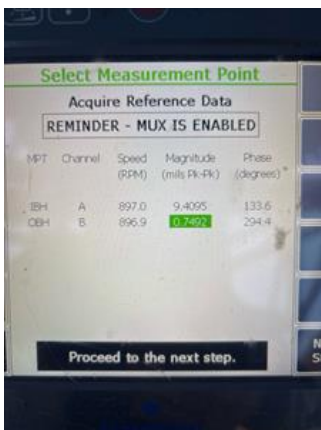
6. Starting Measurements

Left End	Right End
0.7	9.4

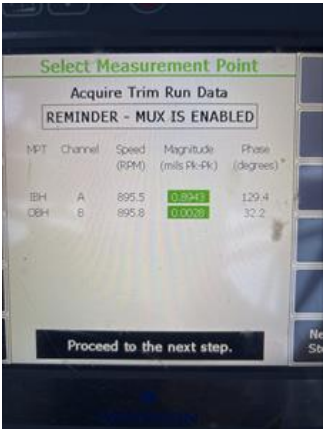
8. Finished Measurements

Left End

0.02

Right End

0.8
