Job Information

Job #: 139640

Motor#: 139640

AC Electrical Inspection

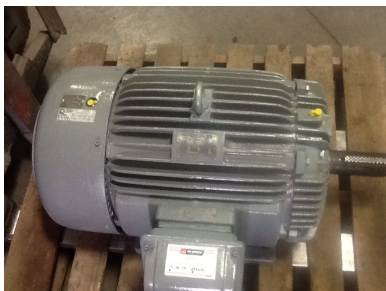
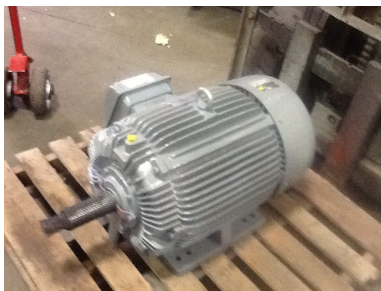
Additional photos

Yes, the shaft has been isolated for delivery.
