Motor Evaluation :

Extruded 2

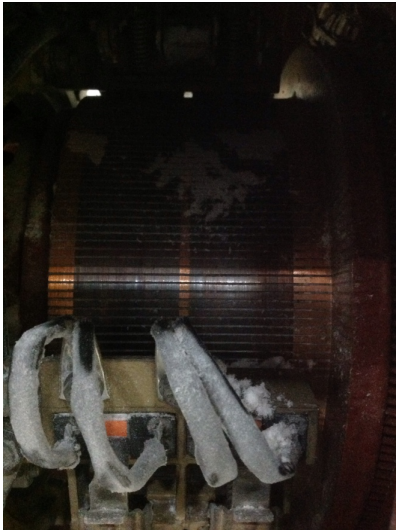
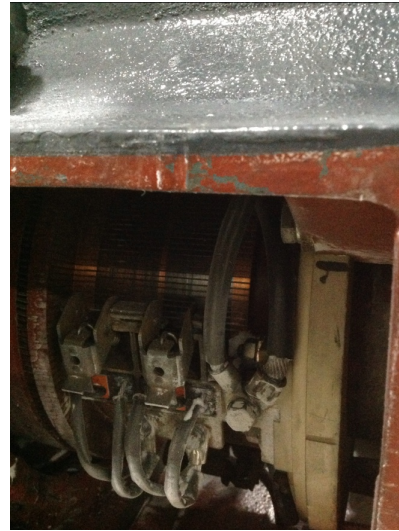
Internal photo

Internal visual appearance :

Dusty

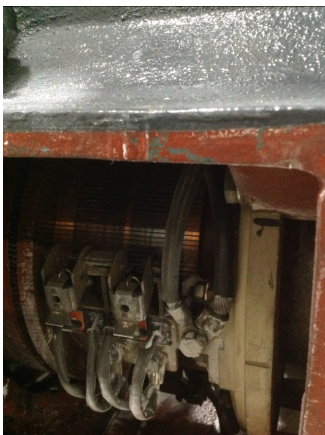
Brush holder

Brush Holders:

Good

Brush Springs:

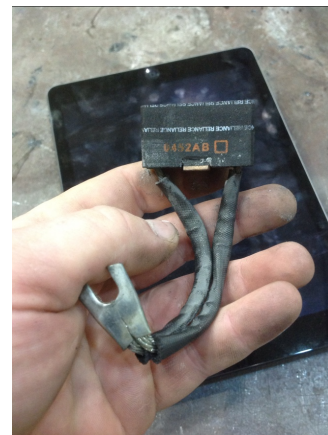
Brush photo

Brushes :

50%

No. Of Brushes:

8

All tests show motor is good. Brushes are worn 50% in the past six months.

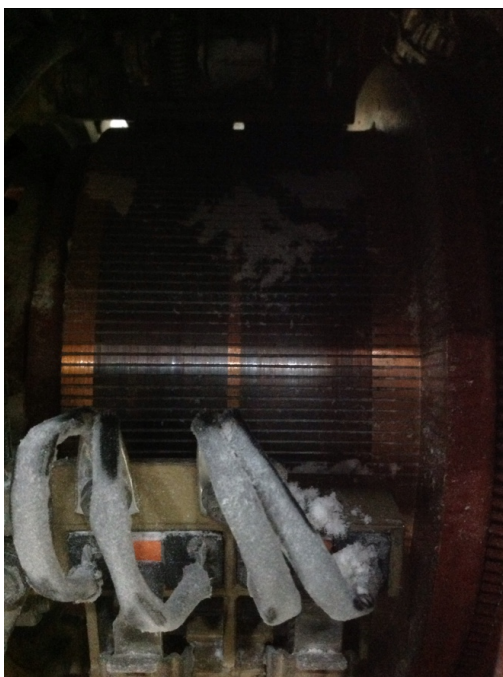
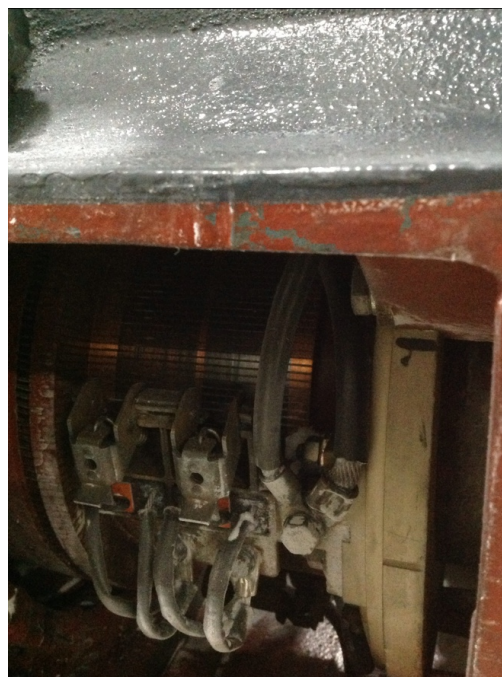
Commutator : Good Smooth Film

Stoned Com: ☒ Yes ☐ No

Comments : All tests show motor is good. Stoned the commutator to remove some of the film. Brushes are worn 50%
