MILLINGTON, TN

March 22, 2021

Company Rockwool

Subject: Fan baseline vibrations

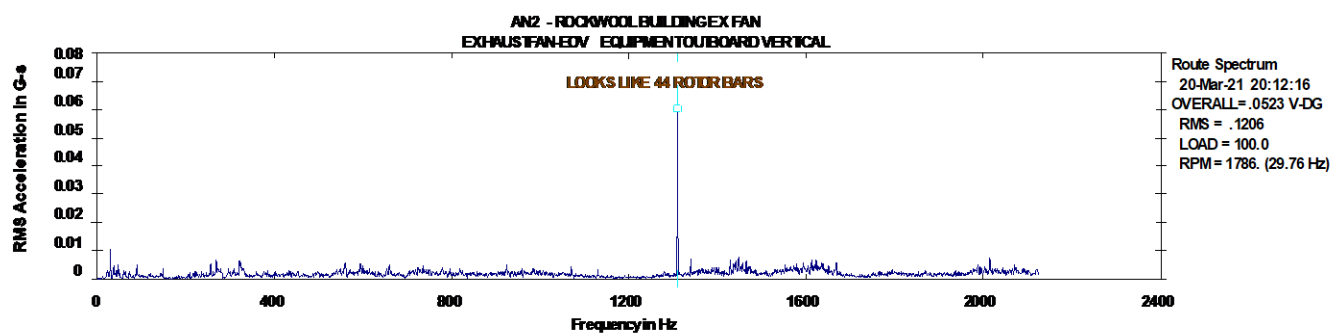
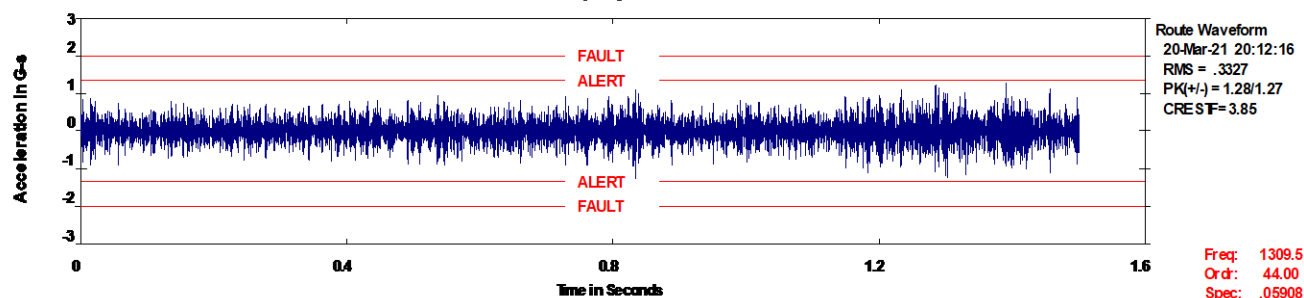
Please find the overall vibration data attached for the two fans that we worked on last Saturday. The SPO fan and the building exhaust fan. A spectrum and waveform are also provided for the Building Exhaust Fan. The vibrations are very good. Note that the exhaust fan overall acceleration is slightly elevated and seems to be either generated by a single vibration peak related to motor rotor bar passing frequency, or vibrations above the fmax of the vibration spectrum we acquired and is of little consequence. Spherical roller bearings which are mounted on this fan generally have more rolling elements and have higher acceleration values. Recommend ensuring those bearings have been greased properly. We appreciate your business.

MEASUREMENT POINT	OVERALL LEVEL	HFD / VHFD	EQUIPMENT SPEED
-----	-----	-----	-----
EXHAUSTFAN - ROCKWOOL BUILDING EX FAN		(20-Mar-21)	
	OVERALL LEVEL	1K-20KHz	
MOH	.081 In/Sec	.301 G-s	1790.0 RPM
MOV	.052 In/Sec	.123 G-s	
MIH	.064 In/Sec	.517 G-s	
MIV	.073 In/Sec	.479 G-s	
MIA	.058 In/Sec	.320 G-s	
EIA	.078 In/Sec	.760 G-s	
EIH	.045 In/Sec	.905 G-s	
EIV	.046 In/Sec	1.186 G-s	
EOH	.046 In/Sec	1.123 G-s	
EOV	.052 In/Sec	1.836 G-s
