IR\_1865.jpg S60 NTSC 21801575

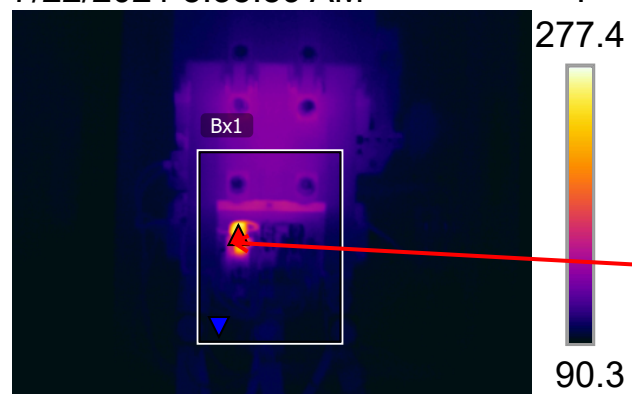
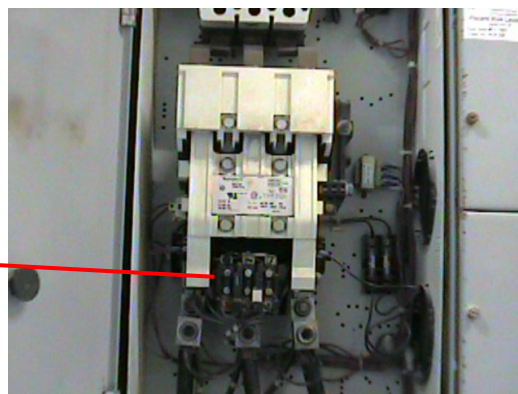
| Bx1 | Max | 267.8 °F |
| | Min | 91.7 °F |
| | Average | 118.5 °F |

Infrared data indicates that the thermal overload is operating at 267\* that is 143\* higher than phases B and C .  
Replace the thermal overload and clean wire and inspect for damage.
