## AC Recondition As Found

**MOST INC (00473501)**  
355 JAMES LAWRENCE RD  
JACKSON, TN 38301

Location: Plant  
Serial Number: 1041037915  
Description: HORIZONTAL AC MOTOR

Hi-Speed Job Number:	148585
Manufacturer:	WEG
Spec/ID #:	MODEL MGP80
Serial Number:	1041037915
HP/kW:	1000 (HP)
RPM:	713 (RPM)
Voltage:	4160
Current:	134.1 (Amps)
Phase:	Three
Hz:	60 (Hz)
Service Factor:	1.15
# of Leads:	3
J-box Included:	Complete
Coupling/Sheave:	Coupling
Date Received:	10/18/2022
Bearing RTDs:	Yes
Stator RTDs:	Yes
Repair Stage:	Final
Rewind:	No
Shaft Machined Fit Repairs Required:	No
Bearing Housing Machined Fit Repairs Required:	No
Heaters:	Yes
Winding Type :	Form Coil
Bearing Type:	Rolling Element

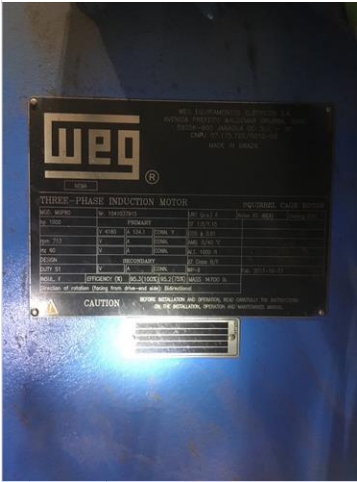
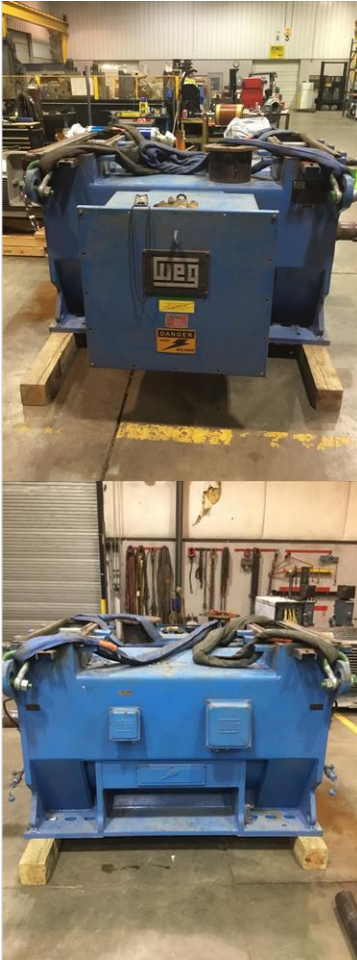
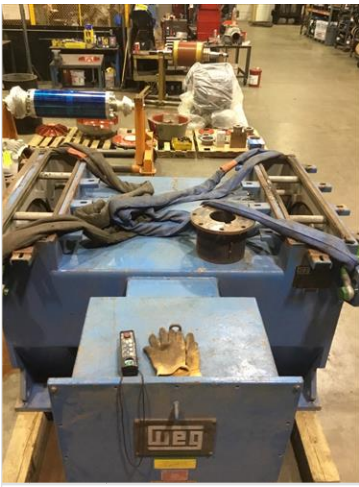
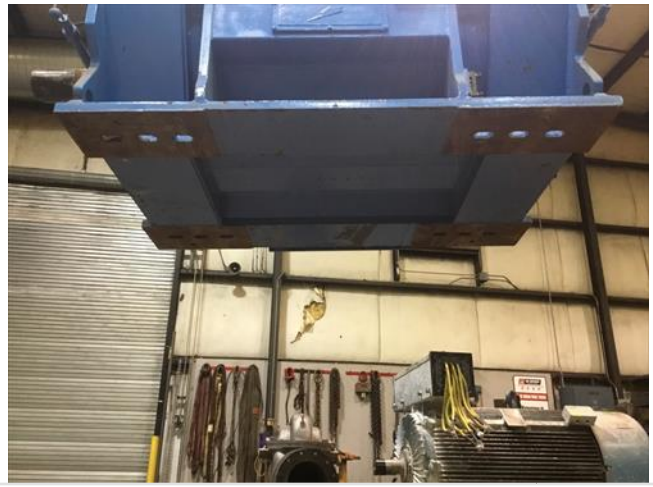
3. Photos of all six sides of the machine.

*Fair, frame has had tabs welded on it to secure what appears to be the hood in the past. Coupling is in poor condition due to impacting from hammering. We highly suggest replacement of coupling, it is included in the quote. The stator failed the surge test. It is possible for a motor to fail the surge test though running. However, it is a warning sign that a failure will likely occur soon. Stator rewind is highly recommended.*

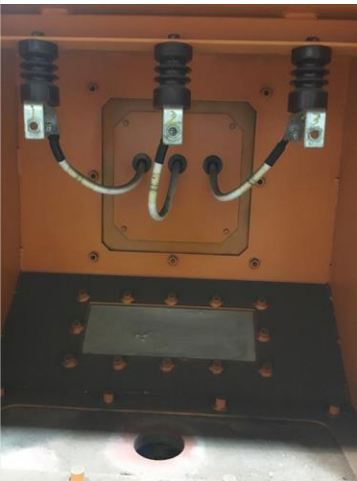
</div>			
12.	Lead Length	32 Inches	P12
<div>Lugged with 3/8 hole 32" from jbox mount plate</div>

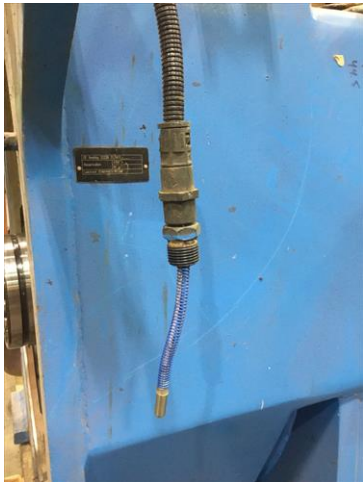
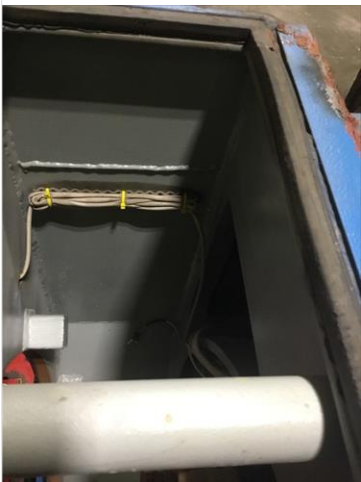
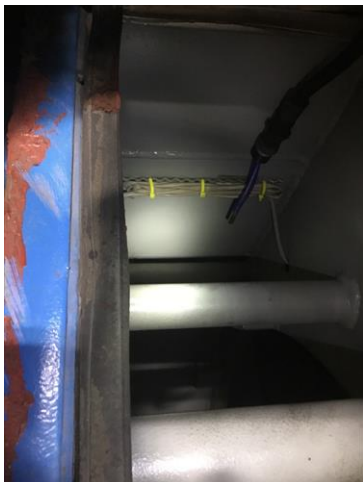
Drive end RTD plastic cracked

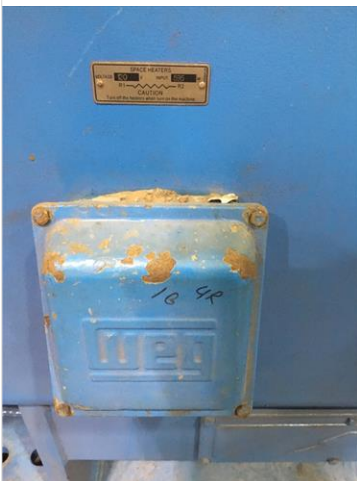
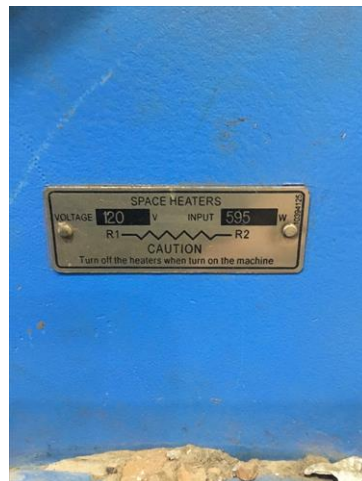
P18

*End bell bolt holes need chased with tap M20x2.5. Two end bell bolts need replaced. M20x2.5 x 75mm. Missing 12 of 16 bolts for electrical panel cover.*

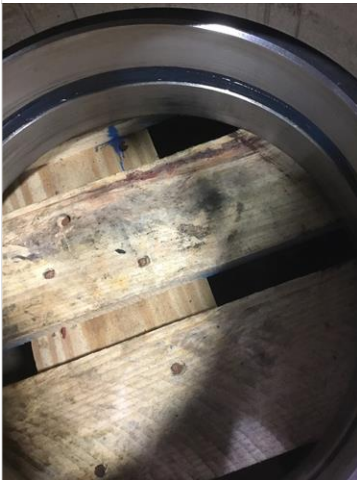
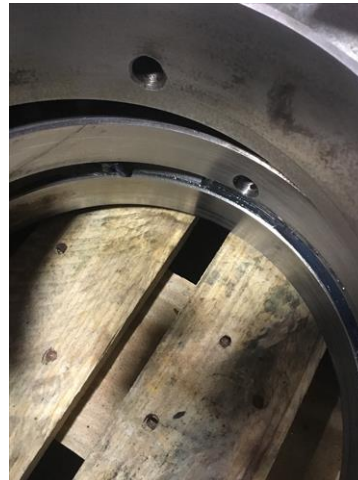
P57

250mm=9.8425. Tolerance is 9.8425-9.8436 within tolerance

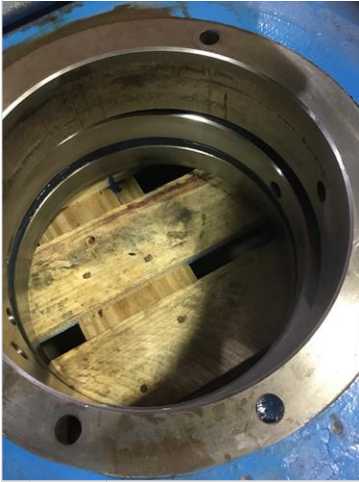
240mm=9.4488. Tolerance is 9.4488-9.4499 within tolerance

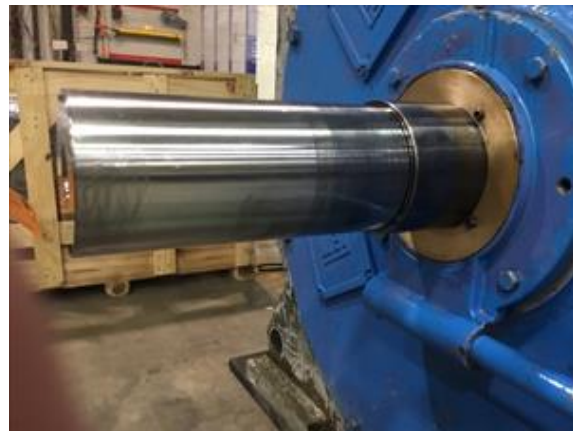
P72

#### 70. Final Insulation Resistance Test

**3769 Megohms**

- 3769 Mohms @ 12kV
- >1000 Mohms @500v after assembly

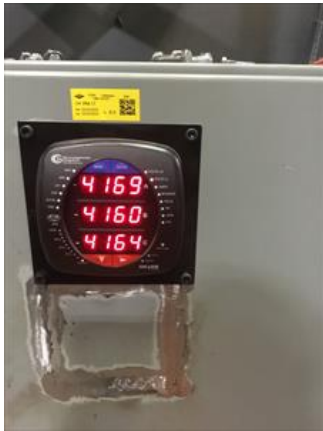
73. Test Run Voltage P75

Volts	Volts	Volts
4169	4160	4164

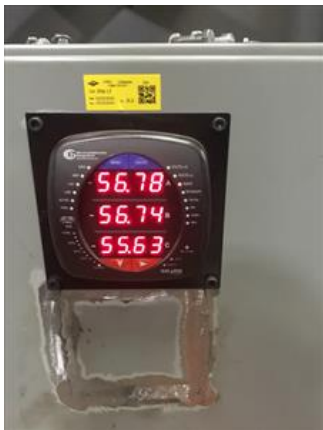
74. Test Run Amperage P76

Amps	Amps	Amps
56.78	56.74	55.63

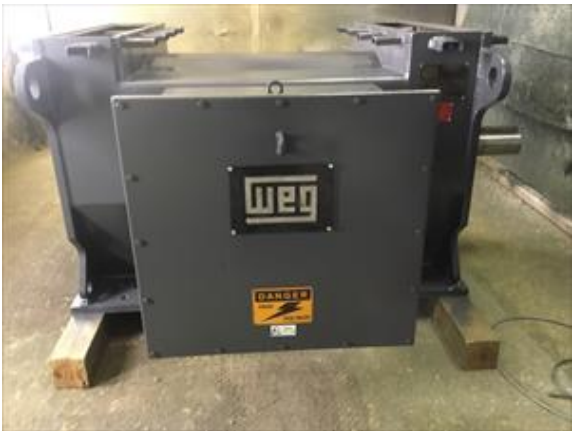
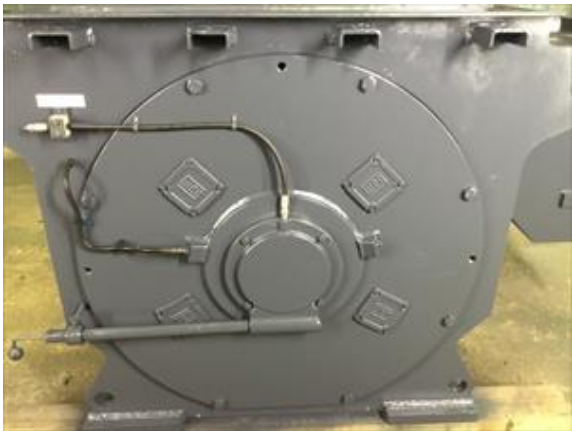
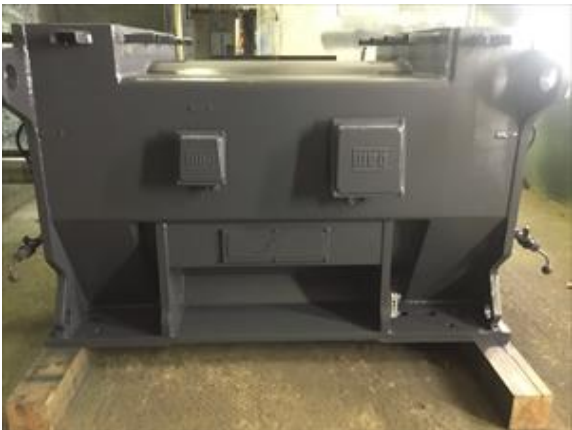
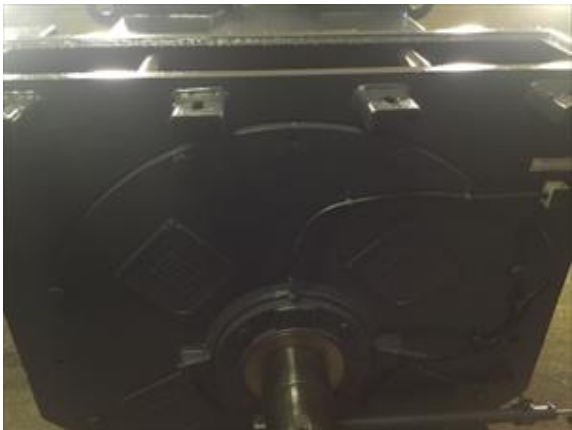
P84

82. Document Final Condition with Pictures after paint
